## **Review of Historic Exploration Drill Sites and Survey of Legacy Effects in the Puhipuhi area, Northland**

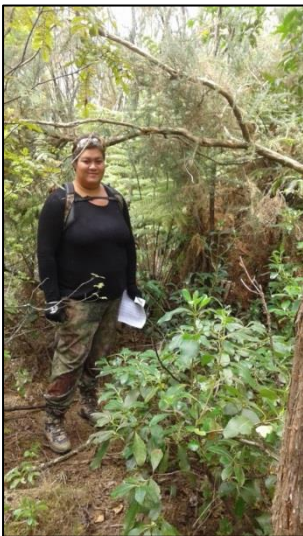
**Site of DDH1** viewed to the EAST

**Drill Site Condition:**

1. Drill Collars: not visible, not located.
2. Site Condition: no visible signs of groundwater seepage, subsidence, hydrocarbons or erosion. All rubbish had been removed.
3. Sediment Control: no sign of sediment runoff.

The drill site is characterised by dense regenerating scrub that is in keeping with surrounding area, except that scrub growth is marginally less dense over former drill site in comparison to surrounding area.

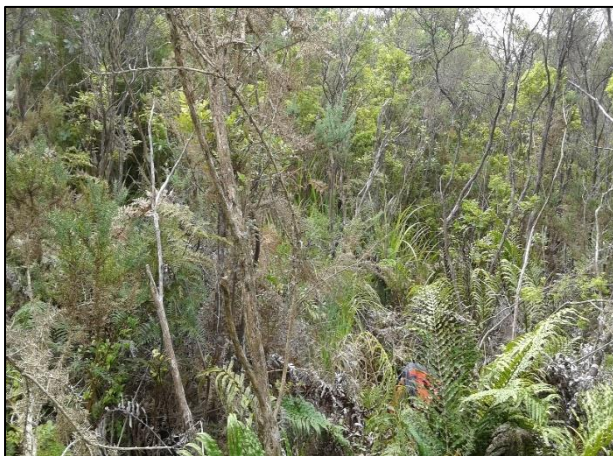
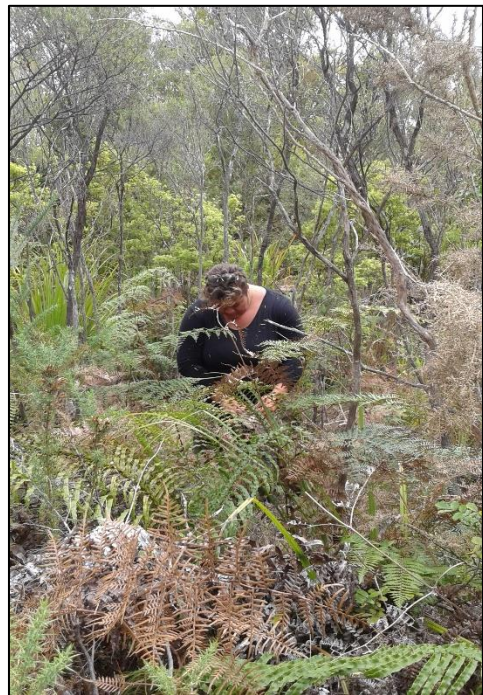
**Site of DDH2 viewed to the EAST**

1. Drill Collar: not visible, not located.
2. Site Condition: no visible signs of groundwater seepage, subsidence, hydrocarbons or erosion. Several pieces of 10-20c m long lengths of drill core found.
3. Sediment Control: no sign of sediment runoff.

Drill site characterised by dense regenerating scrub that is in keeping with surrounding area, except that scrub growth is marginally less dense over former drill site in comparison to surrounding area. Area surrounding has common totara which is absent on the drill site.

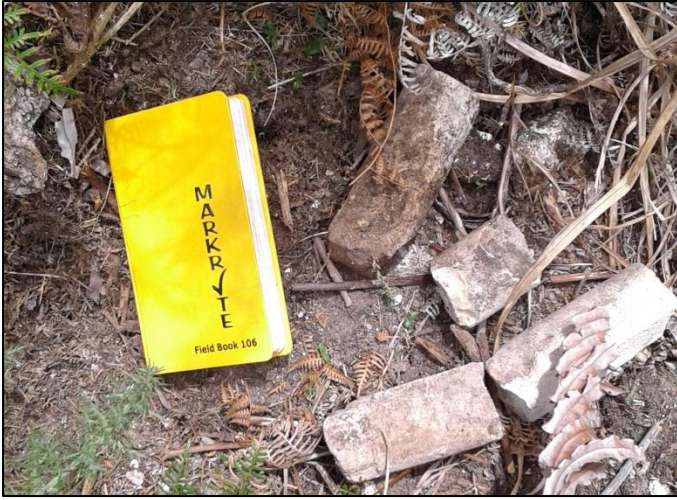
**Fragments of core at the site of DDH2**

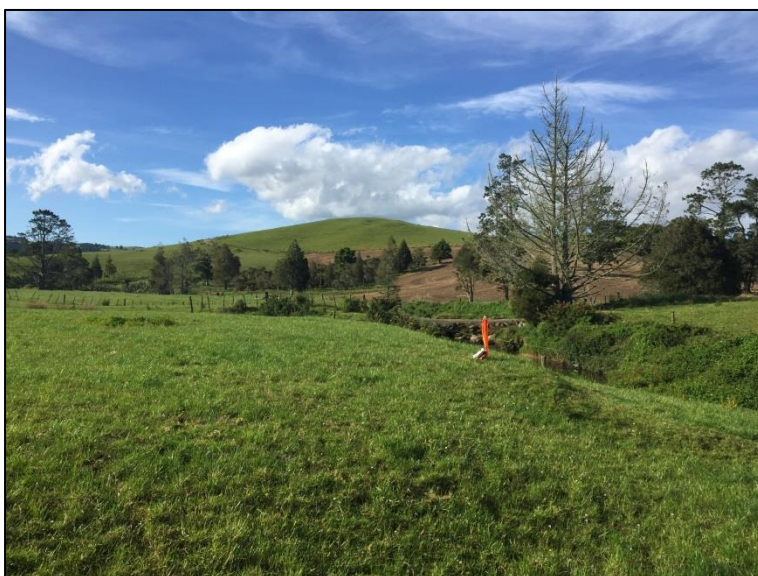
**Site of PDDH4A and PDDH4 (viewed to the NORTH)**

1. Drill Collars: not visible, not located.
2. Site Condition: no visible signs of groundwater seepage, subsidence, hydrocarbons or erosion. All rubbish had been removed.
3. Sediment Control: no sign of sediment runoff, all cuttings have been removed.

No physical or environmental evidence of drill sites found. Drill collar not definitively located with probe.

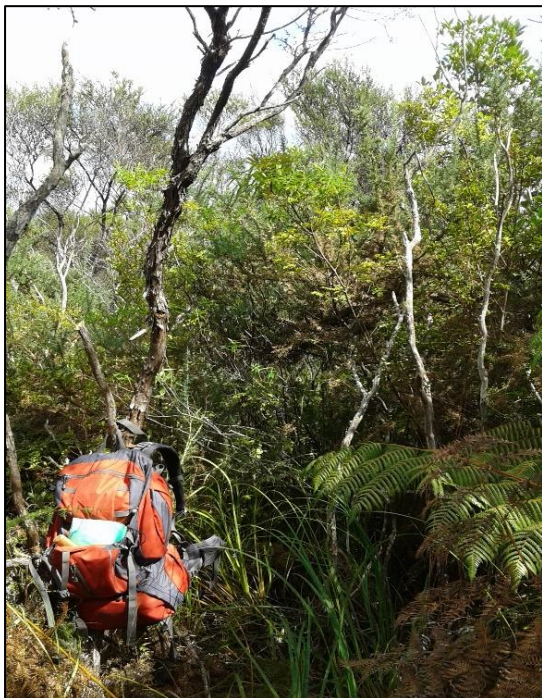
**Site of PPRC1 (viewed to the WEST)**

1. Drill Collar: not visible, not located.
2. Site Condition: no visible signs of groundwater seepage, subsidence, hydrocarbons or erosion. All rubbish had been removed.
3. Sediment Control: no sign of sediment runoff.

Area characterized by abundant gorse, fern and various ground-cover plant species. Regrowth over ~30 years since completion of this drill hole makes it difficult to determine the precise location of the previously disturbed drill area.

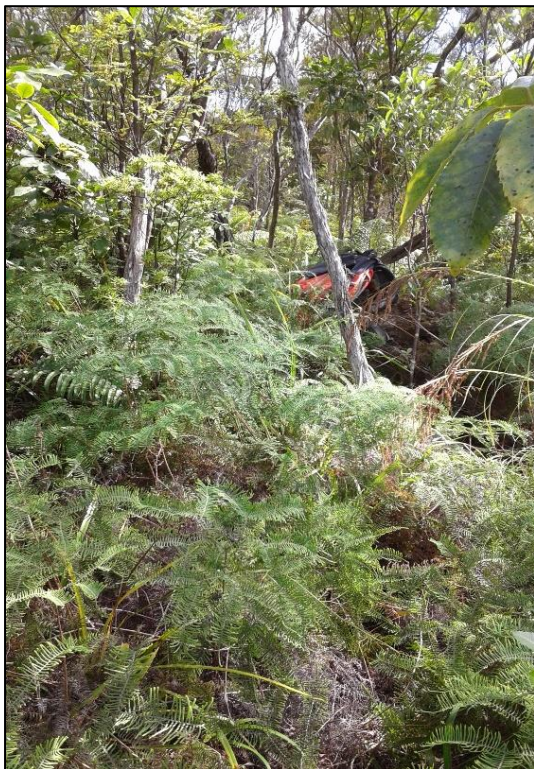
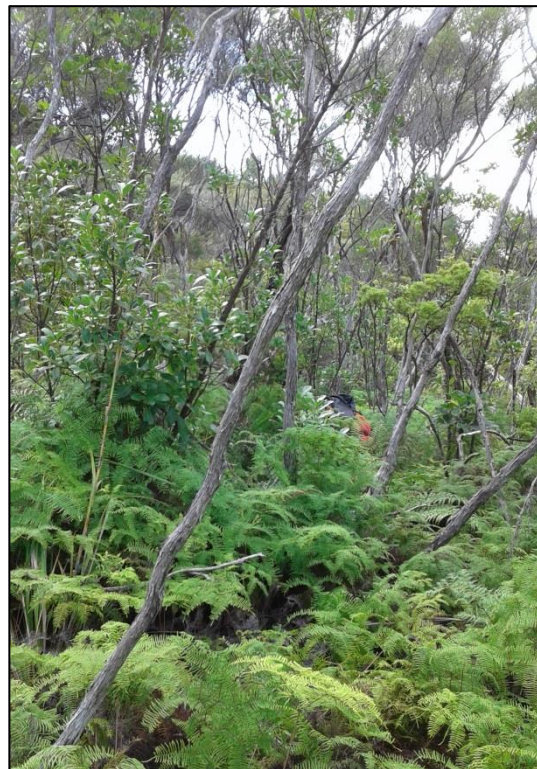
**Site of PPRC2 (viewed to the WEST)**

1. Drill Collar: not visible, not located.
2. Site Condition: no visible signs of groundwater seepage, subsidence, hydrocarbons or erosion. All rubbish had been removed.
3. Sediment Control: no sign of sediment runoff, all cuttings have been removed.

Area characterized by abundant manuka, fern and various ground-cover plant species. Regrowth over ~30 years since completion of this drill hole makes it difficult to determine the precise location of the previously disturbed drill area. No obvious signs of earthworks.

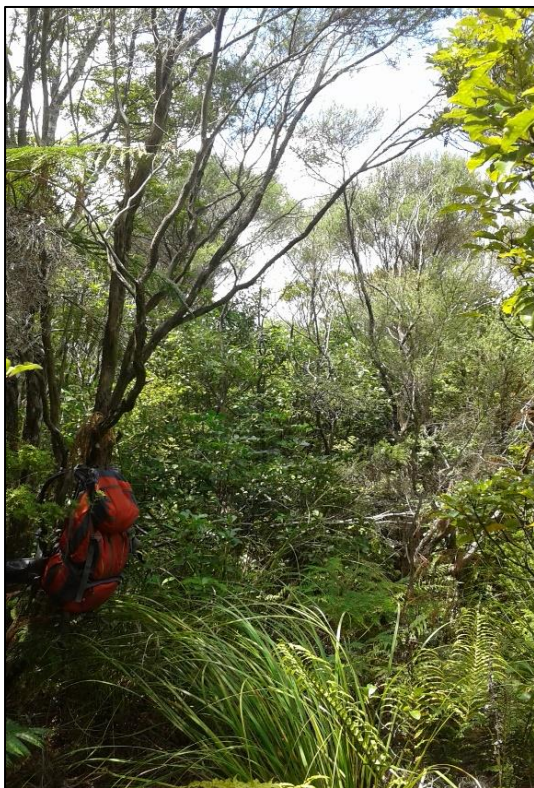
**Site of PPRC3** (viewed to the NORTH)

1. Drill Collar: not visible, not located.
2. Site Condition: no visible signs of groundwater seepage, subsidence, hydrocarbons or erosion. Rubbish had been removed (a 10cm length of 130mm PVC pipe found).
3. Sediment Control: no sign of sediment runoff, all cuttings have been removed.

Drill site characterised by dense regenerating scrub that is in keeping with surrounding area, except that scrub growth is marginally less dense over former drill site in comparison to surrounding area. 10cm length of PVC pipe (drill collar casing?) found near site.

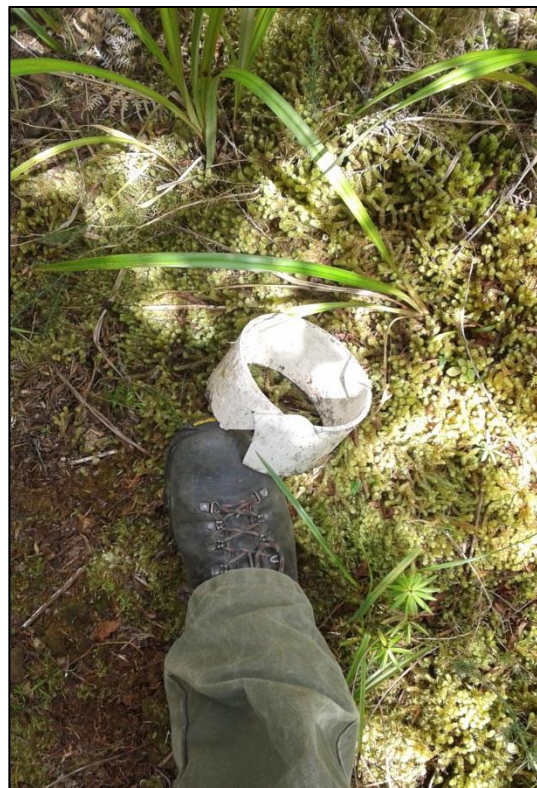
**Site of PPRC3** (piece of PVC piping found at site)

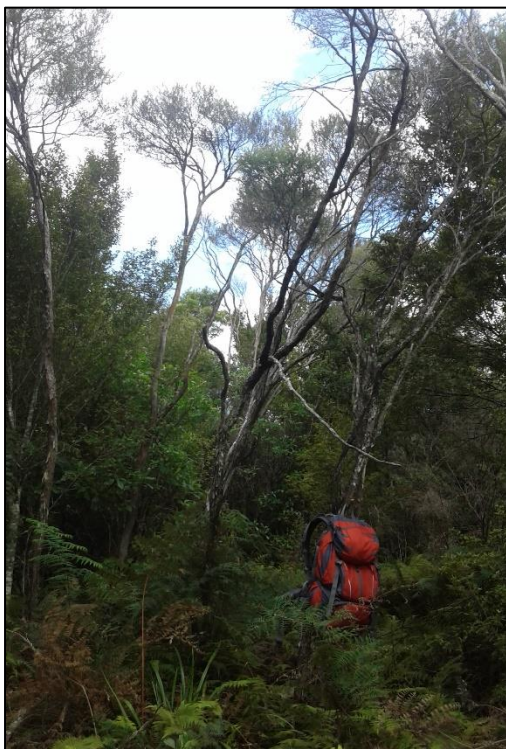
**Site of PPRC4** (viewed to the WEST)

1. Drill Collar: not visible, not located.
2. Site Condition: no visible signs of groundwater seepage, subsidence, hydrocarbons or erosion. All rubbish had been removed.
3. Sediment Control: no sign of sediment runoff, all cuttings have been removed.

The drill site is characterised by scrub growth (abundant fern and ground cover) that is less dense than the surrounding area which is defined by abundant manuka.

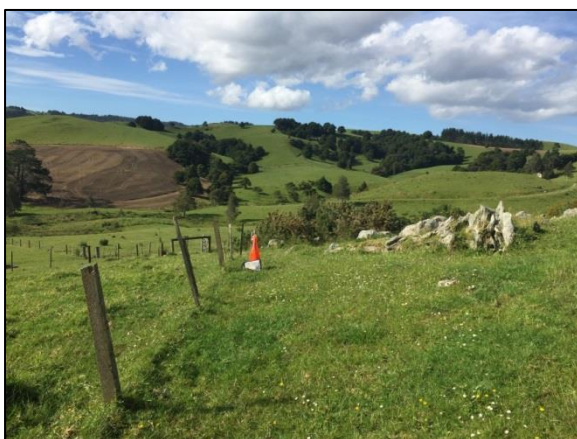
**Site of PPRC5 collar (viewed to the NORTH)**

1. Drill Collars: not visible, not located.
2. Site Condition: no visible signs of groundwater seepage, subsidence, hydrocarbons or erosion. All rubbish had been removed.
3. Sediment Control: no sign of sediment runoff, all cuttings have been removed.

No physical or environmental evidence of drill site found. Drill collars not definitively located with probe due to (buried) boulders present in the area.

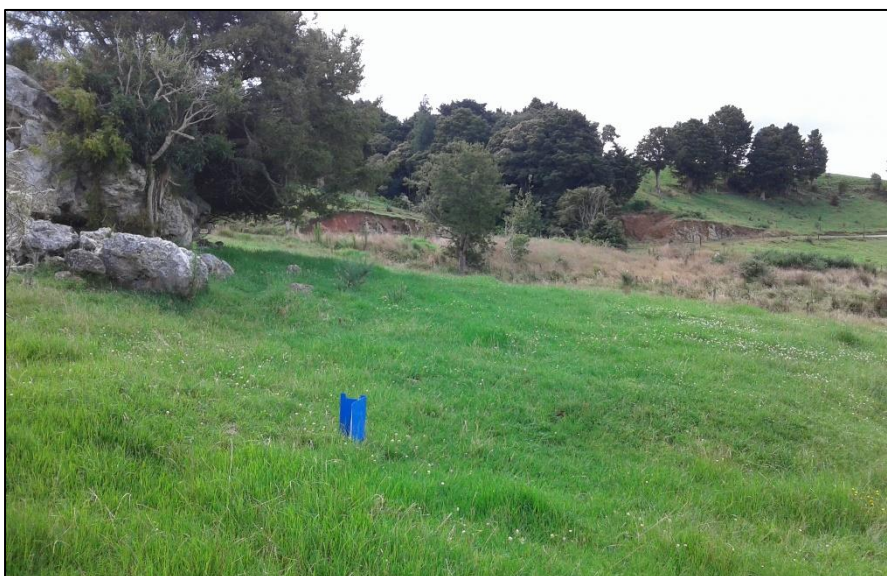
**Site of PPRC7 (viewed to the NORTH)**

1. Drill Collars: not visible, not located.
2. Site Condition: no visible signs of groundwater seepage, subsidence, hydrocarbons or erosion. All rubbish had been removed.
3. Sediment Control: no sign of sediment runoff, all cuttings have been removed.

Drill collars not located. No physical or environmental evidence of drill site found. Area located between 5m and 25m from river bank.

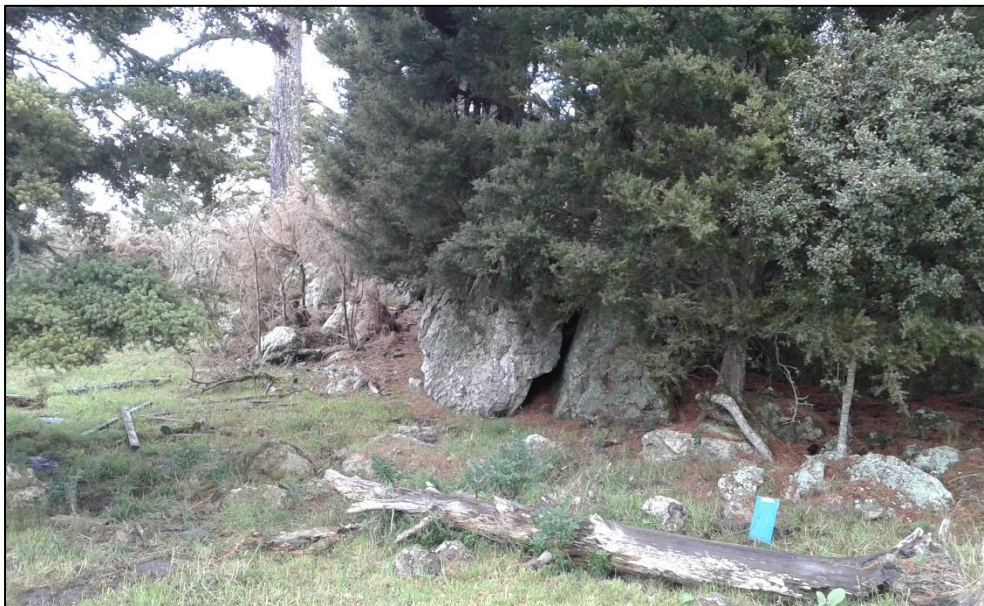
**Site of PPRC9** (viewed to the SOUTH-EAST)

1. Drill Collars: not visible, not located.
2. Site Condition: no visible signs of groundwater seepage, subsidence, hydrocarbons or erosion. All rubbish had been removed.
3. Sediment Control: no sign of sediment runoff, all cuttings have been removed.

Drill collar not found. Area located within paddock that encloses outcropping rock with scattered pine trees and totara. No physical or environmental evidence of a drill site.

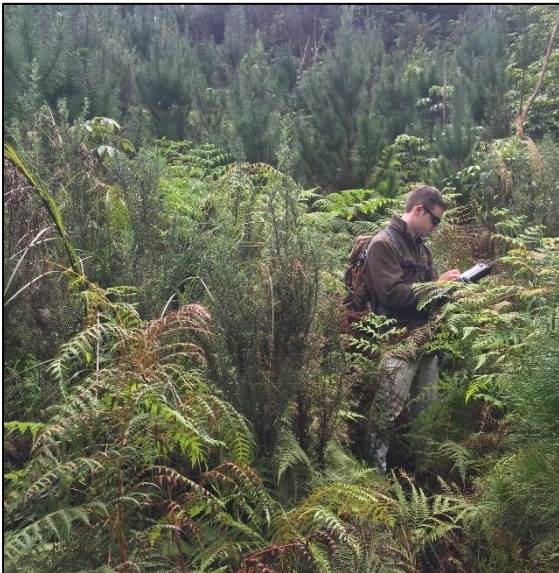
**Site of PPRC10** (viewed to the NORTH)

1. Drill Collar: not visible, not located.
2. Site Condition: no visible signs of groundwater seepage, subsidence, hydrocarbons or erosion. All rubbish had been removed.
3. Sediment Control: no sign of sediment runoff, all cuttings have been removed.

Drill Collar was unable to be located. Very dense gorse, scrub and juvenile Radiata pine trees. Difficult to assess current state of surface or any potential disturbance from drill activities due to recent forestry harvesting and replanting.

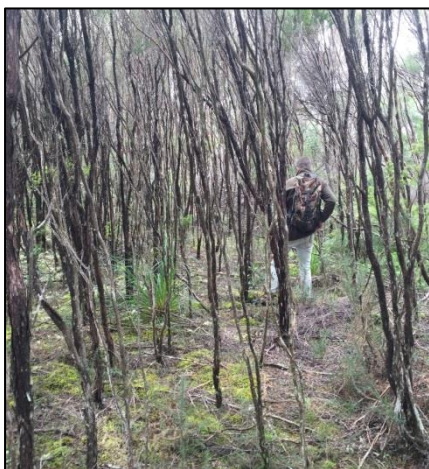
Site of PPRC11 and PPRC33 (viewed to the NORTH)

1. Drill Collars: not visible, not located.
2. Site Condition: no visible signs of groundwater seepage, subsidence, hydrocarbons or erosion. All rubbish had been removed. Two shallow pools of standing water, 2-4m wide, at edge of site.
3. Sediment Control: no sign of sediment runoff, all cuttings have been removed.

Drill collar was not located. Site clearance activities are evident as minor grading of ground surface. The site is characterised by abundant “pole” manuka (trunk width 2cm to 5cm) and a marked reduction in undergrowth relative to undisturbed land. The site has an approximate diameter of 12m. There are two small areas of shallow standing water at edges of site but unclear of their relation to the holes and probably represent rainwater pooling in low points.

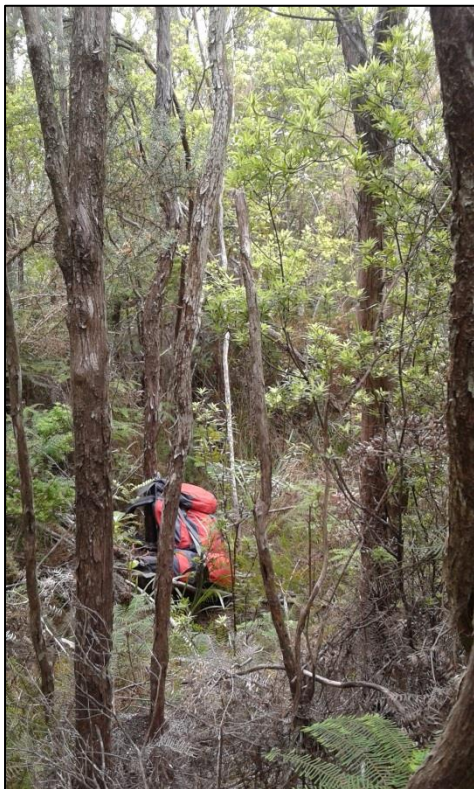
**Site of PPRC13 (viewed to the NORTH)**

1. Drill Collar: not visible, not located.
2. Site Condition: no visible signs of groundwater seepage, subsidence, erosion or hydrocarbons. All rubbish had been removed.
3. Sediment Control: no sign of sediment runoff, all cuttings have been removed.

Drill collar not located. No physical or environmental evidence of drill site found. Remains of vehicle track discernible in places.

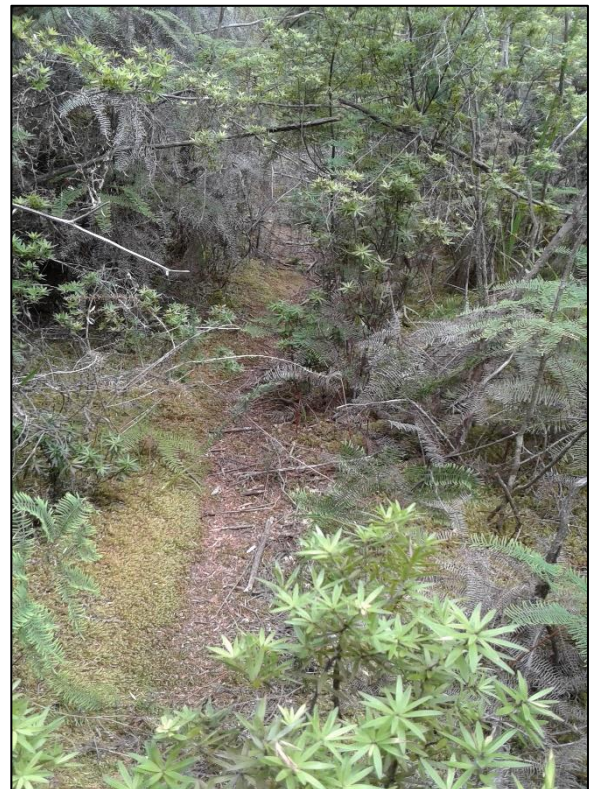
The drill collars were not located at any of these sites, having been capped below surface. There is no evidence of soil erosion or groundwater seepage at these sites. Small fragments of drill core were found at the site of DDH2 and a piece of PVC pipe, possibly representing the cut-off upper section of drill collar casing, was found at the site of PPRC3. Photographs of these articles are included with the site descriptions in Appendix 1. The remains of a vehicle access track are discernible in places. The track is extensively revegetated but evidence of wheel ruts remain as linear depressions approximately 10cm deep (photo, PPRC13, Appendix 1).

**Track to PPRC13 (viewed to the WEST)**

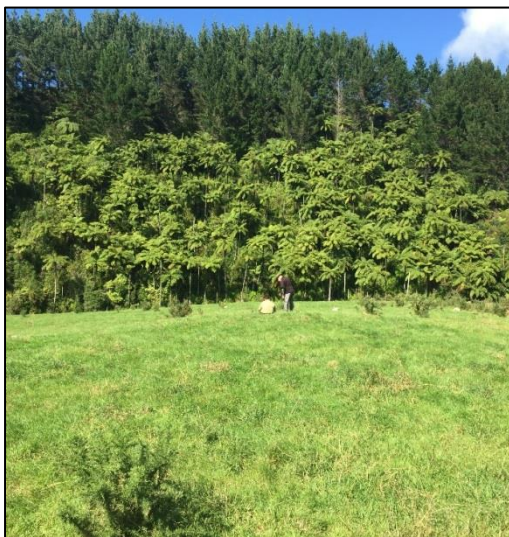
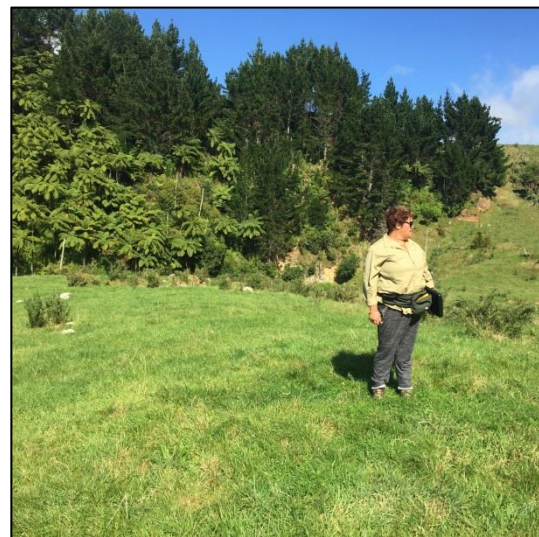
**Site of PPRC14 (viewed to the SOUTH)**

1. Drill Collar: not visible, probed but not located.
2. Site Condition: no visible signs of groundwater seepage, subsidence, erosion or hydrocarbons. All rubbish had been removed.
3. Sediment Control: no sign of sediment runoff, all cuttings have been removed.

Drill collar not located. No physical or environmental evidence of drill site found.

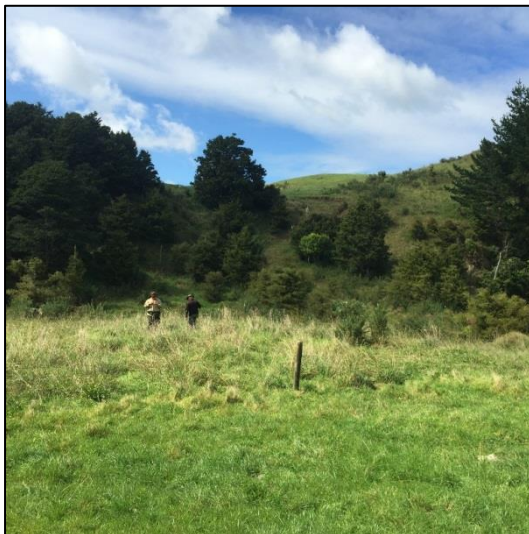
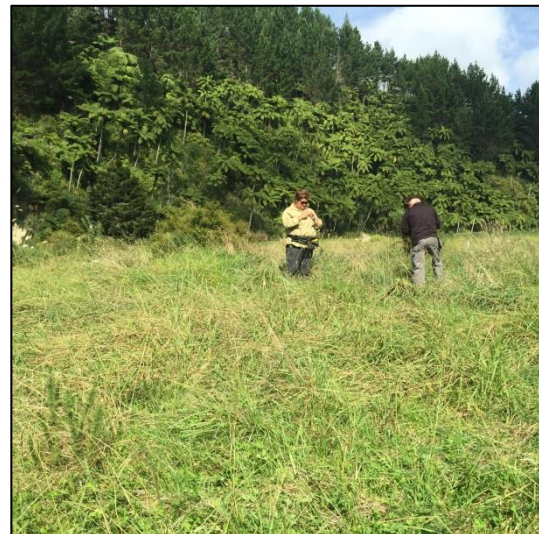
**Site of PPRC15 and PPRC16 (viewed to the EAST)**

1. Drill Collars: not visible, probed but not located.
2. Site Condition: no visible signs of groundwater seepage, subsidence, erosion or hydrocarbons. All rubbish had been removed.
3. Sediment Control: no sign of sediment runoff, all cuttings have been removed.

PPRC15 and PPRC16 have the same collar location. Drill collars not located. No physical or environmental evidence of drill site found.

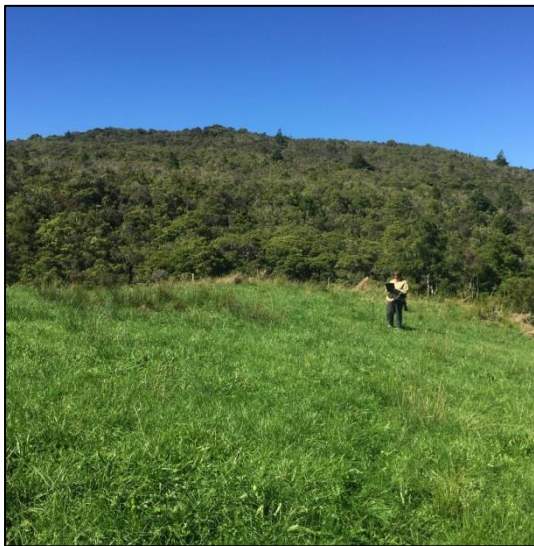
**Site of PPRC17 and PPRC18 (viewed to the EAST)**

1. Drill Collars: not visible, probed but not located.
2. Site Condition: no visible signs of groundwater seepage, subsidence, erosion or hydrocarbons. All rubbish had been removed.
3. Sediment Control: no sign of sediment runoff, all cuttings have been removed.

PPRC17 and PPRC18 have the same collar location. No physical or environmental evidence of drill site found. Drill collars / caps not definitively located with probe due to abundant boulders (sinter) present in the area.

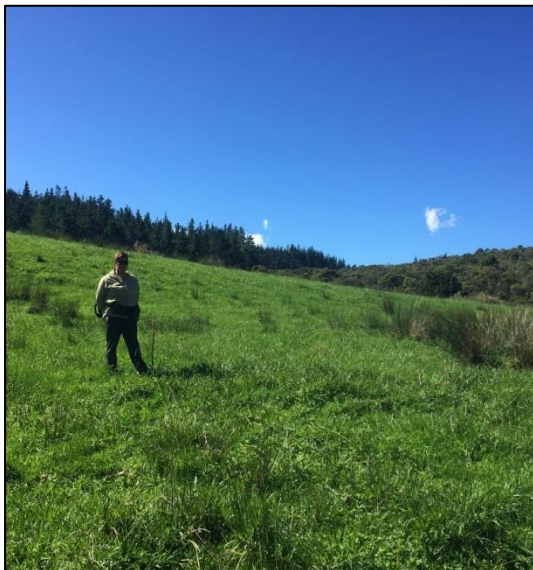
**Site of PPRC19** (viewed to the NORTH)

1. Drill Collar: not visible, probed but not located.
2. Site Condition: no visible signs of groundwater seepage, subsidence, erosion or hydrocarbons. All rubbish had been removed.
3. Sediment Control: no sign of sediment runoff, all cuttings have been removed.

No physical or environmental evidence of drill site found. Drill collar / cap not definitively located with probe due to (buried) boulders present in the area.

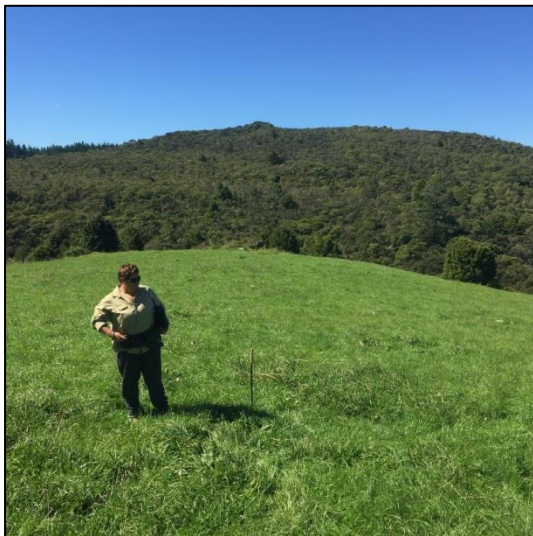
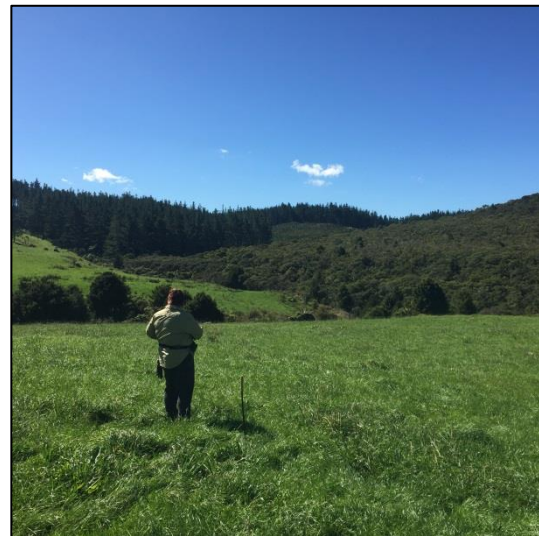
**Site of PPRC20 (viewed to the EAST)**

1. Drill Collar: not visible, probed but not located.
2. Site Condition: no visible signs of groundwater seepage, subsidence, erosion or hydrocarbons. All rubbish had been removed.
3. Sediment Control: no sign of sediment runoff, all cuttings have been removed.

No physical or environmental evidence of drill site found. Drill collar / cap not definitively located with probe due to (buried) boulders present in the area.

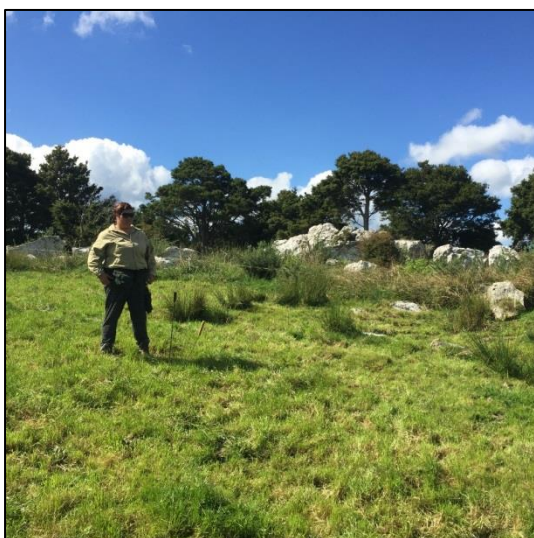
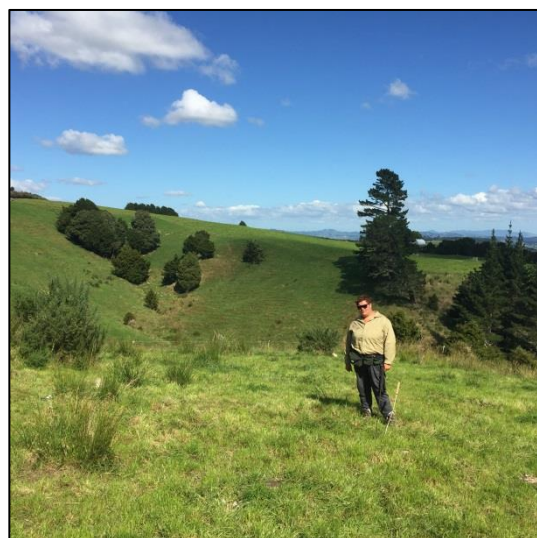
**Site of PPRC21 and PPRC22 (viewed to the EAST)**

1. Drill Collars: not visible, probed but not located.
2. Site Condition: no visible signs of groundwater seepage, subsidence, erosion or hydrocarbons. All rubbish had been removed.
3. Sediment Control: no sign of sediment runoff, all cuttings have been removed.

No physical or environmental evidence of drill site found. Drill collars / caps not definitively located with probe due to (buried) boulders present in the area.

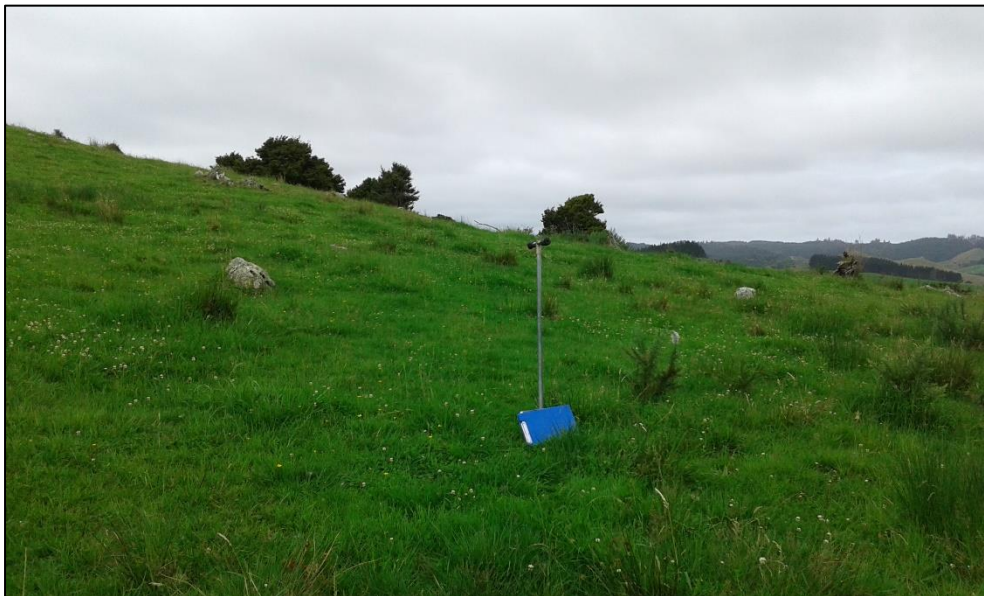
**Site of PPRC24** (viewed to the NORTH)

1. Drill Collar: not visible, not located.
2. Site Condition: no visible groundwater seepage, subsidence, erosion or hydrocarbons. All rubbish had been removed.
3. Sediment Control: no sign of sediment runoff, all cuttings have been removed.

Drill collar not located. Area located in paddock with scattered gorse. No physical or environmental evidence of drill site found.

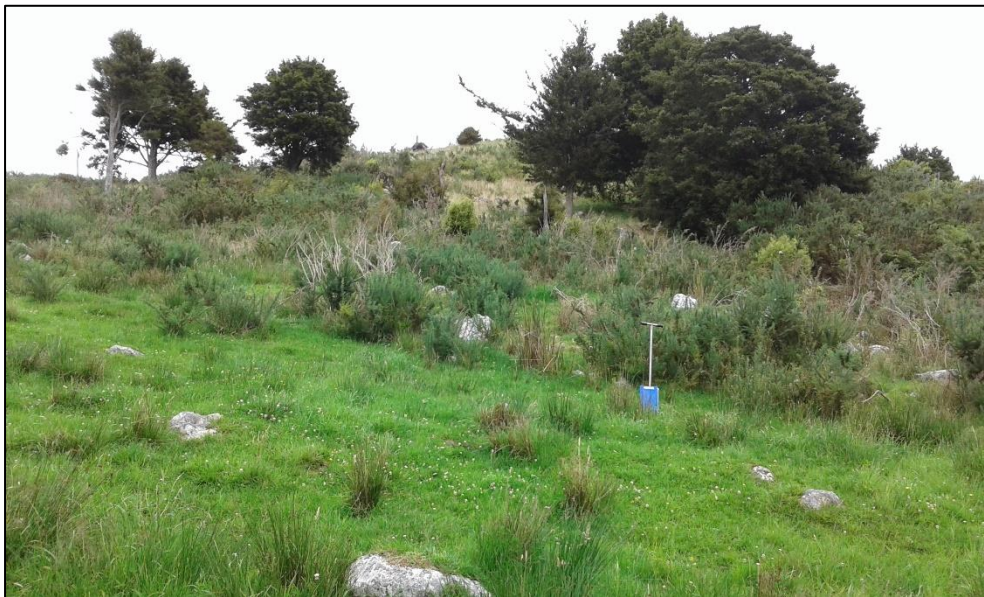
**Site of PPRC25 (viewed to the WEST)**

1. Drill Collar: not visible, not located.
2. Site Condition: no visible groundwater seepage, subsidence, erosion or hydrocarbons. All rubbish had been removed.
3. Sediment Control: no sign of sediment runoff, all cuttings have been removed.

Drill collar not found. Drill site located at the base of gorse-covered hill. No physical or environmental evidence for drill site found.

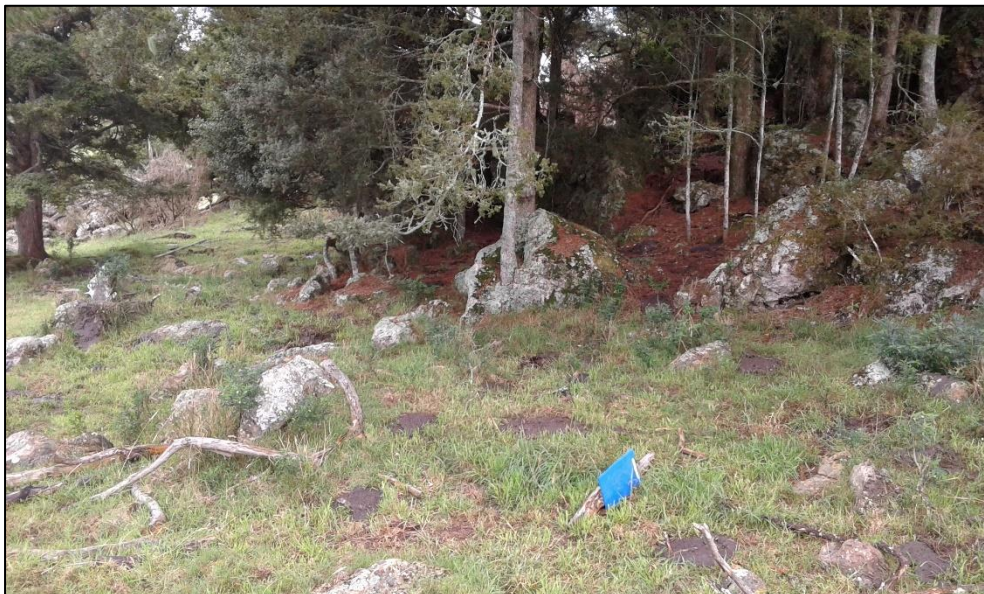
**Site of PPRC26 (viewed to the EAST)**

1. Drill Collar: not visible, not located.
2. Site Condition: no visible groundwater seepage, subsidence, erosion or hydrocarbons. All rubbish had been removed.
3. Sediment Control: no sign of sediment runoff, all cuttings have been removed.

Drill collar not found. Area located in paddock that encloses outcropping sinter, with scattered pine trees and totara. No physical or environmental evidence of Drillsite found.

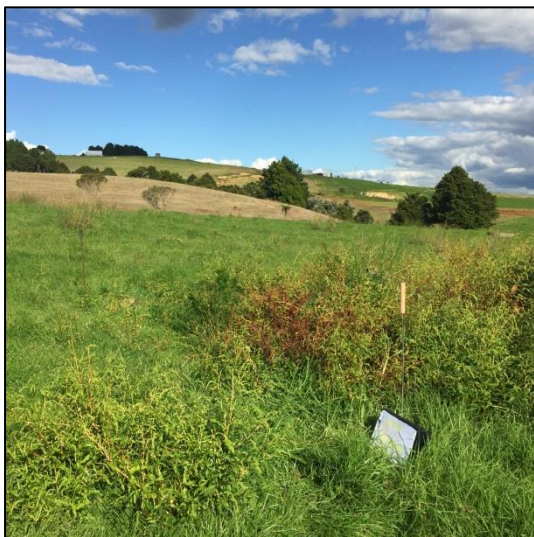
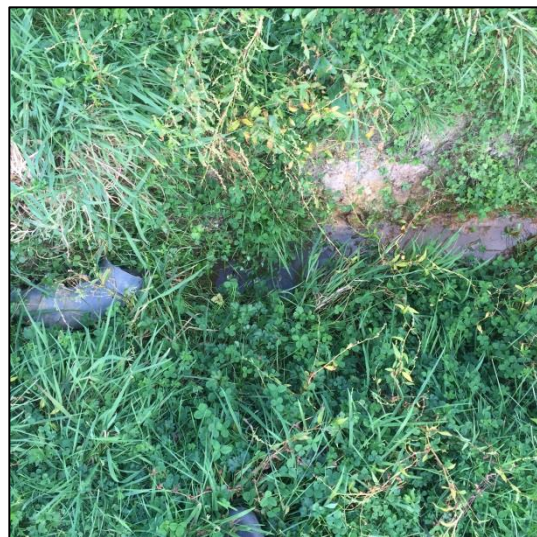
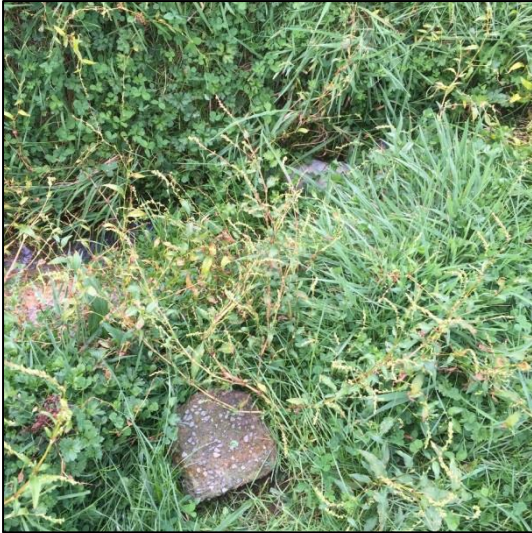
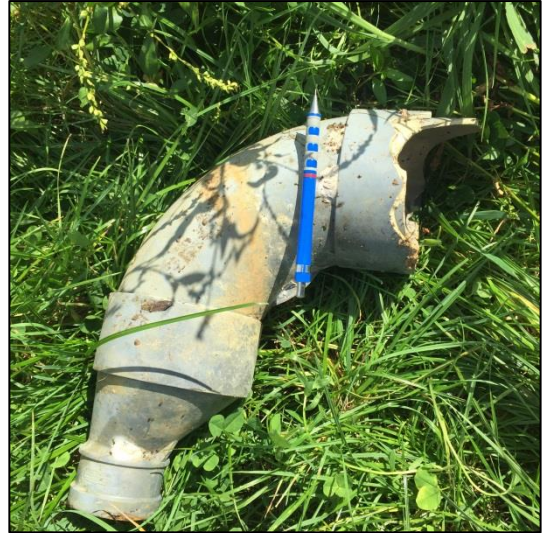
**PPRC27**

Groundwater seepage was observed only at one site, PPRC27, where recent earthworks by the landowner has exposed the drill collar. The water discharge from this hole is <5 L/minute.

1. Drill Collar: buried drill collar located.
2. Site Condition: visible groundwater seepage, no subsidence, erosion or hydrocarbons.
3. Sediment Control: no sign of sediment runoff, all cuttings have been removed.

The site occurs at the edge of a boggy area characterised by tall weed growth. In 2014 the new land owner excavated a series of trenches in order to drain this boggy pasture, and in the process exposed the collar of PPRC27. Water is expressing from the collar of this drill hole at a flow rate <5L/minute and passes into a drainage trench. The collar had previously been fitted with a PVC T-piece to which alkathene piping had been fitted to manage the artesian flow (fragments located). The collar possibly had a small concrete cap (fragment located).

**Site of PPRC27 (marked with a black-handled probe) and PPRC28 (marked by the clipboard) (view to SOUTH)**

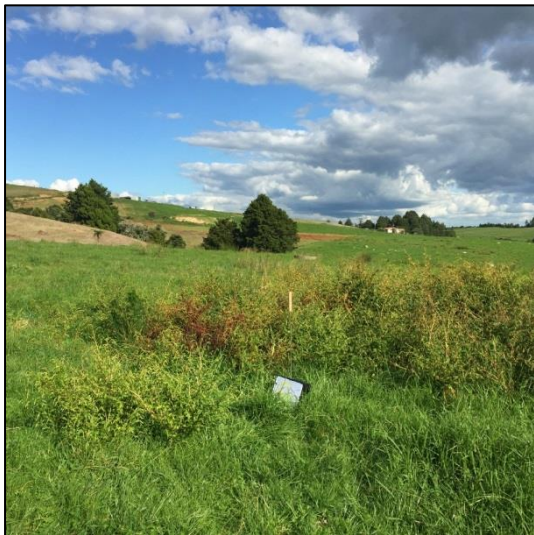
**Site of PPRC28 (viewed to the SOUTH)**

1. Drill Collar: not visible, probed and possibly located at a depth of 50cm.
2. Site Condition: no visible groundwater seepage but site occurs within a boggy area approximately 3m W of PPRC27. No visible subsidence, erosion or hydrocarbons. All rubbish had been removed.
3. Sediment Control: No sign of sediment runoff, all cuttings have been removed.

PPRC28 was drilled approximately 3m W of PPRC27. Collar not located but a possible buried collar cap was located at a depth of 50cm. The site lies on the edge of a boggy area characterised by tall weed growth.

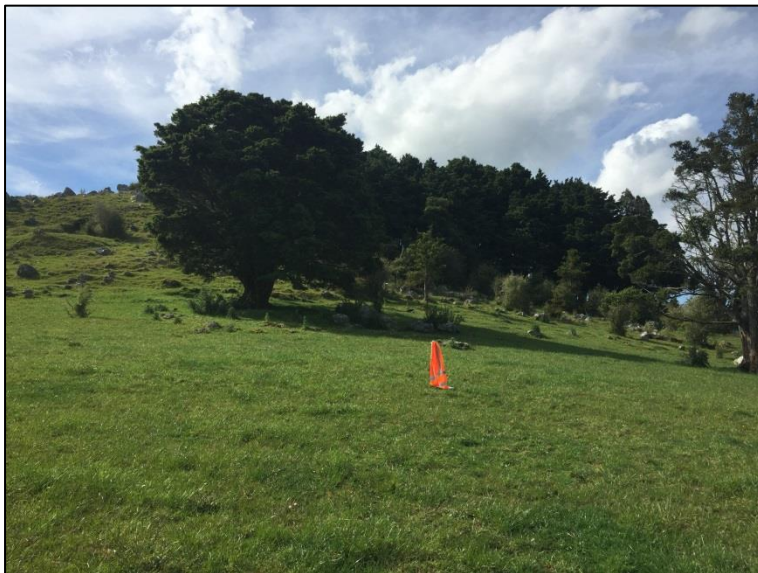
**Site of PPRC29 (viewed to the NORTH)**

1. Drill Collar: not visible, not located.
2. Site Condition: no visible signs of groundwater seepage, subsidence, hydrocarbons or erosion. All rubbish had been removed.
3. Sediment Control: no sign of sediment runoff, all cuttings have been removed.

No physical or environmental evidence of drill site found. Drill collar not definitively located with probe due to (buried) boulders present in the area.

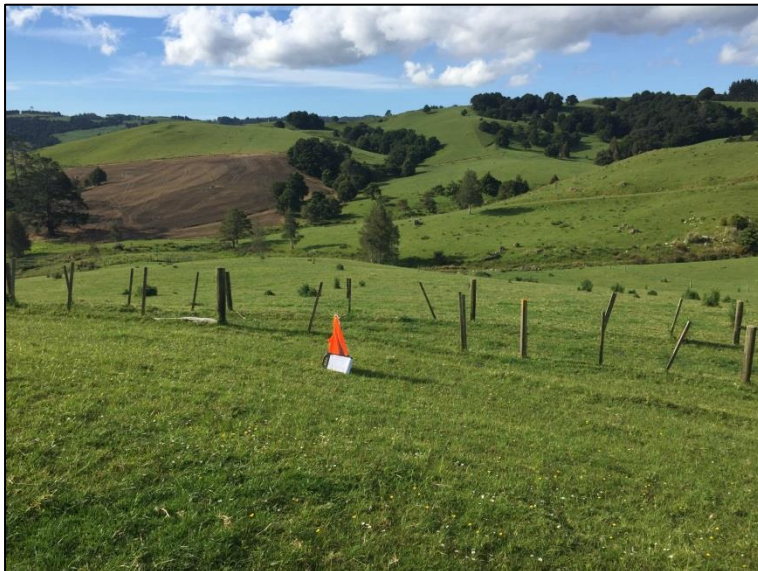
**Site of PPRC30 and PPRC31 (viewed to the NORTH)**

Holes PPRC30 and PPRC31 were drilled from the same location. No physical or environmental evidence of drill site found. Drill collar not definitively located with probe due to (buried) boulders present in the area.

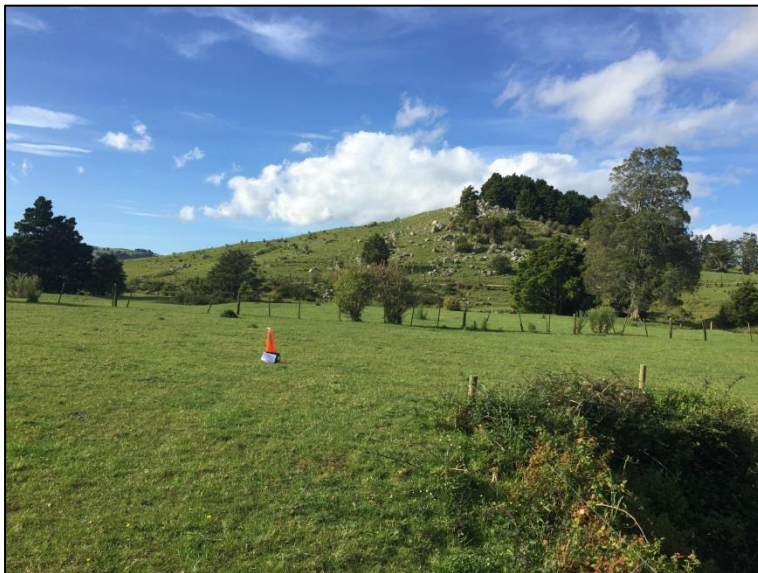
**Site of PPRC32 (viewed to the NORTH)**

No physical or environmental evidence of drill site found. Drill collar not definitively located with probe.

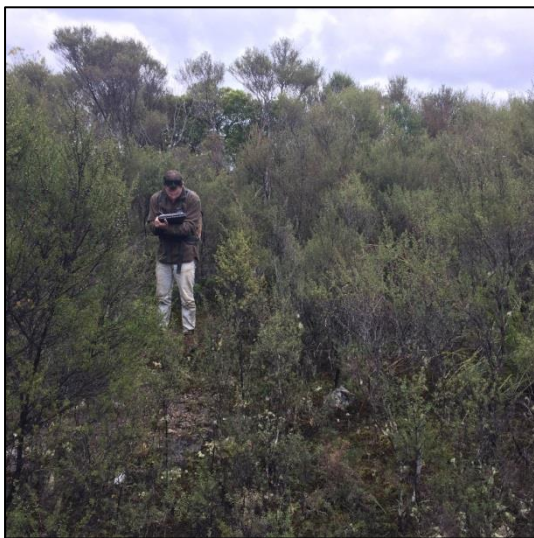
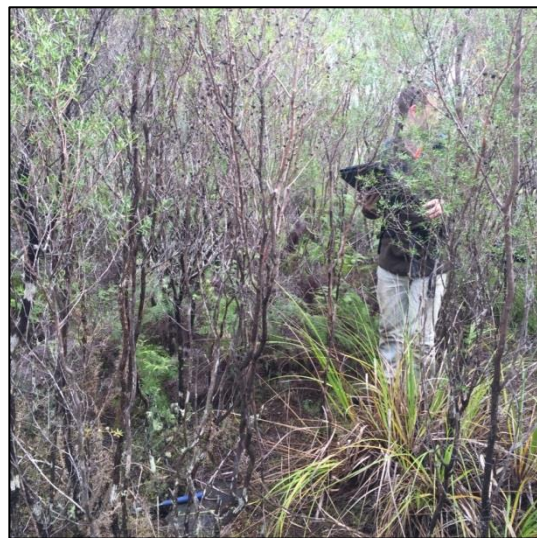
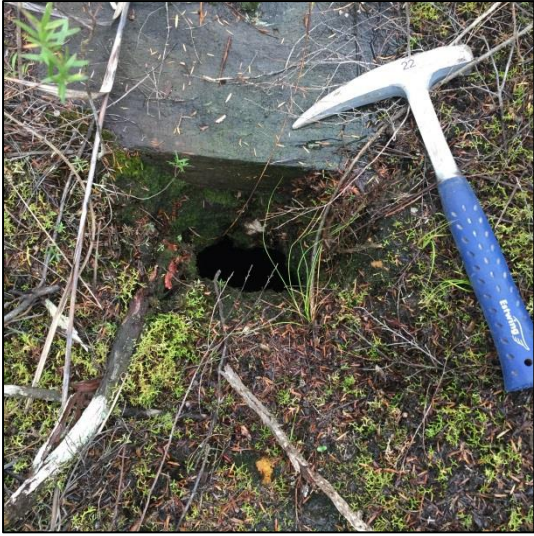
**PPRC34 and PPRC34A collar**

Minor surface levelling on topographic high-point is evident. Collar located, partially capped with a wooden block. The drill hole is blocked 1.25m below surface (water has pooled above the blockage). The site is characterised by dense manuka scrub, with thinner undergrowth relative to the surrounding area.

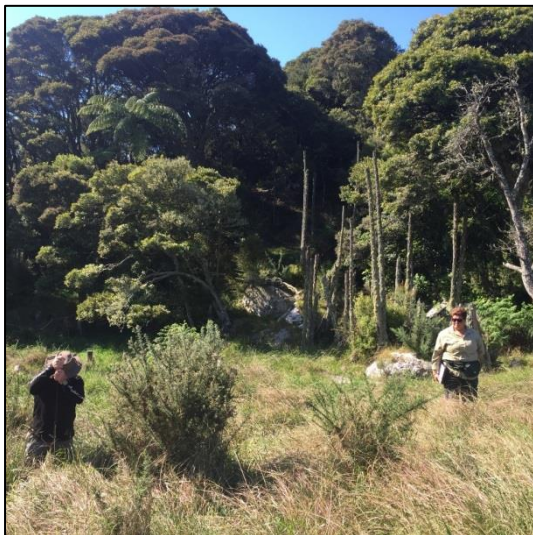
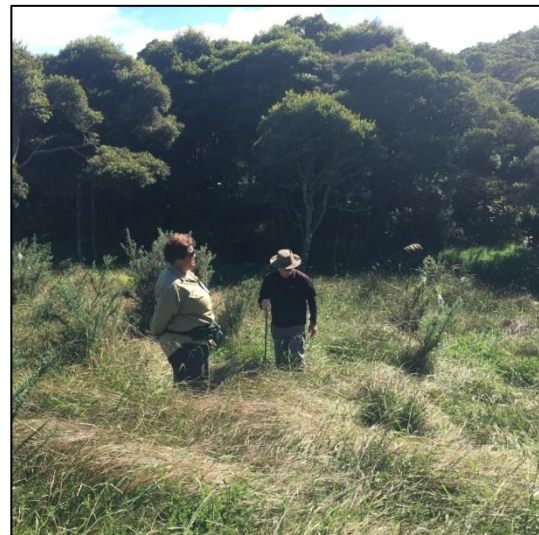
**Site of PRC35 (viewed to the EAST)**

Drill collar not visible and not located by probing. No physical or environmental evidence of drill site found. The land owner asked the surveyor to account for discolouration in the general area of the drill site. No discolouration was found.

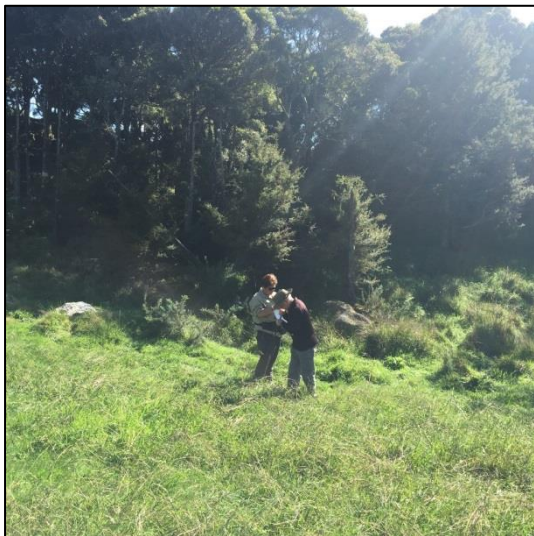
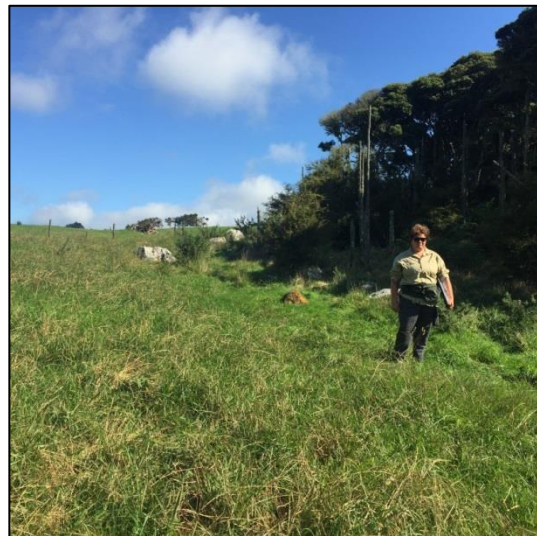
**Site of PRC36 (viewed to the NORTH)**

Drill collar not visible and not located by probing. No physical or environmental evidence of drill site found.

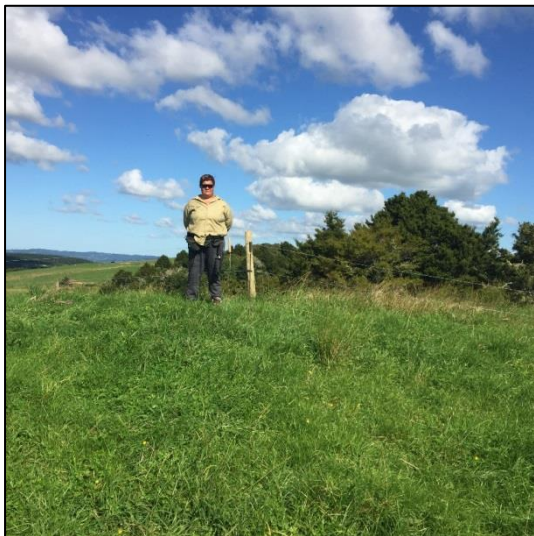
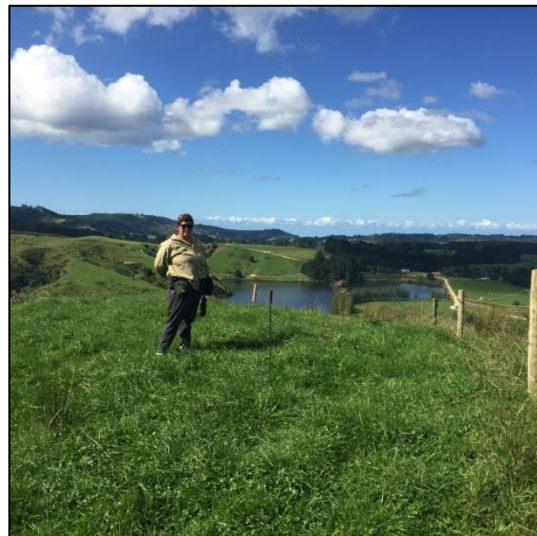
**Site of PRC37 (viewed to the SOUTH)**

The site is located on the flat crest of a low hill. Drill collar not visible and not located by probing. No physical or environmental evidence of drill site found.

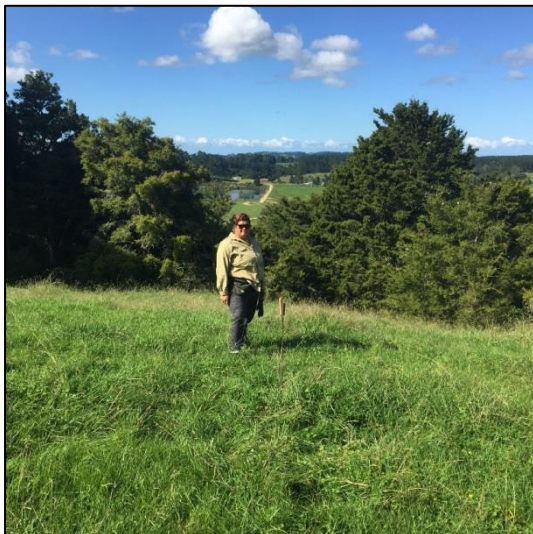
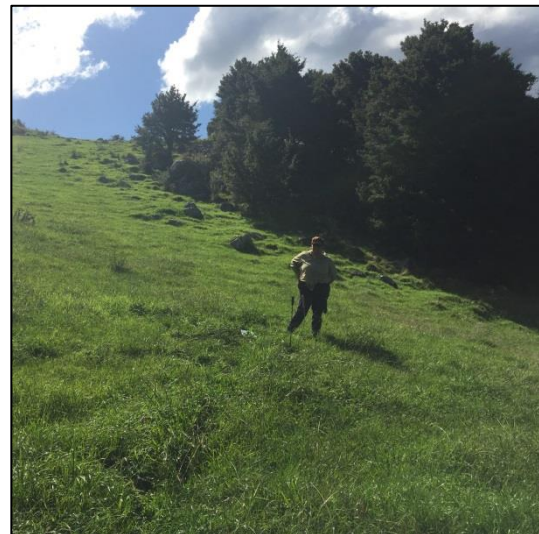
**Site of PRC38 (viewed to the EAST)**

Drill collar not visible and not located by probing due to abundant buried boulders. No physical or environmental evidence of drill site found.

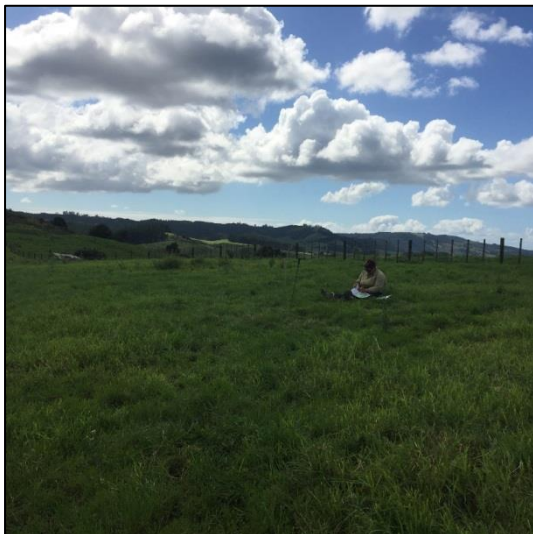
**Site of PRC39 (viewed to the NORTHEAST)**

Drill collar not visible and not located by probing. No physical or environmental evidence of drill site found.

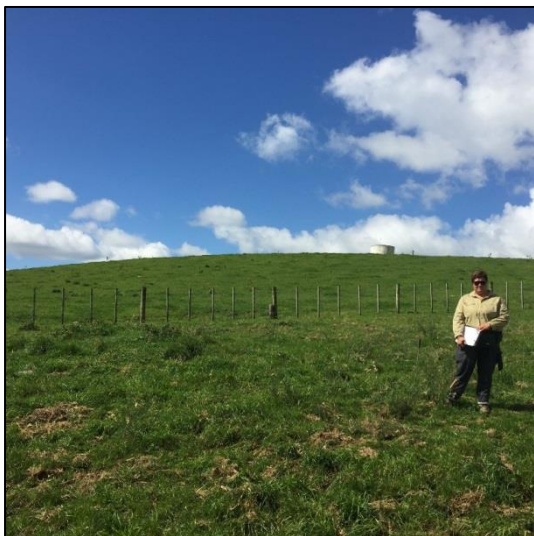
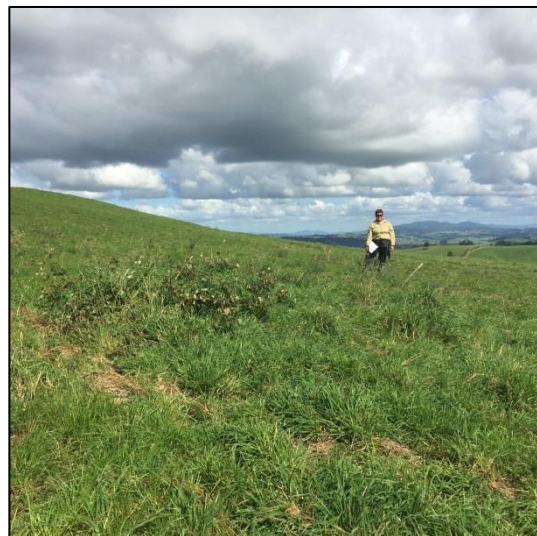
**Site of PRC41 (viewed to the EAST)**

Drill collar not visible but possibly located by probing . No physical or environmental evidence of drill site found. A low mound of soil (grassed) occurs approximately 5m east of collar site (approx. 1m high, 2.5m wide) but believed to be an agricultural feature.
