## **Review of Historic Exploration Drill Sites and Survey of Legacy Effects in the Puhipuhi area, Northland**

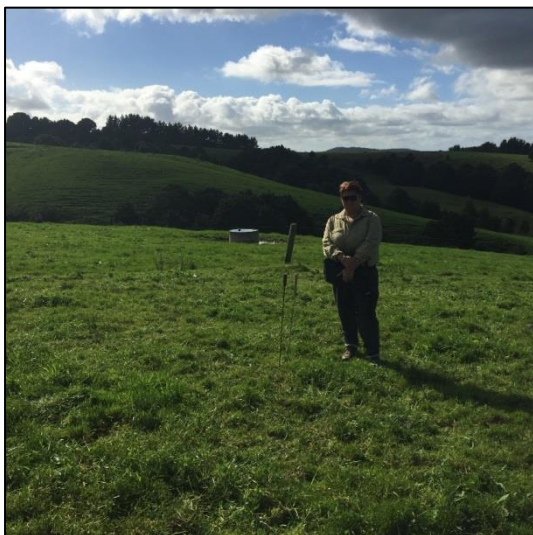
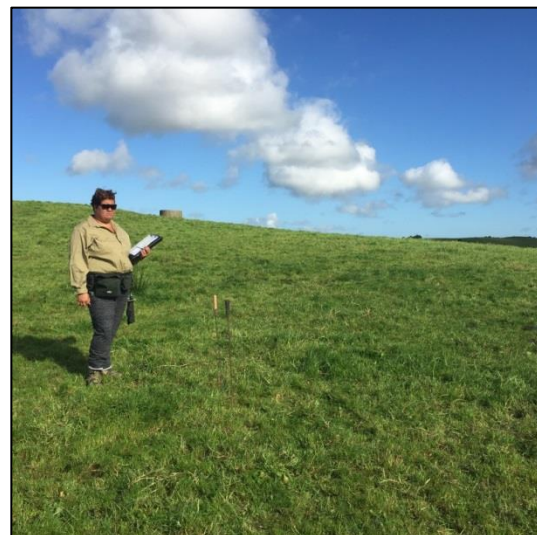
**Site of PRC42 (viewed to the EAST)**

Drill collar not visible but possibly located by probe . No physical or environmental evidence of drill site found.

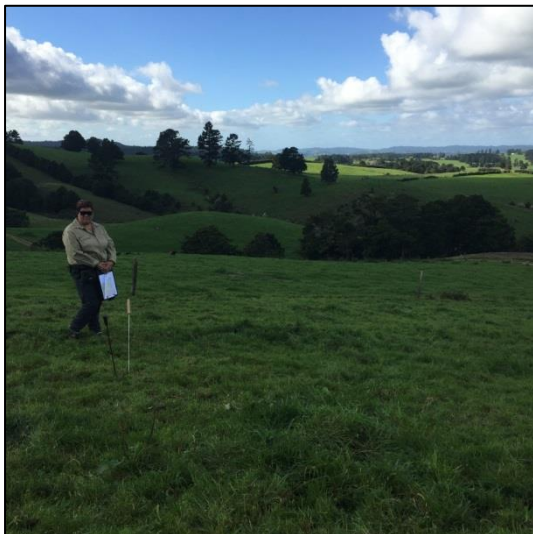
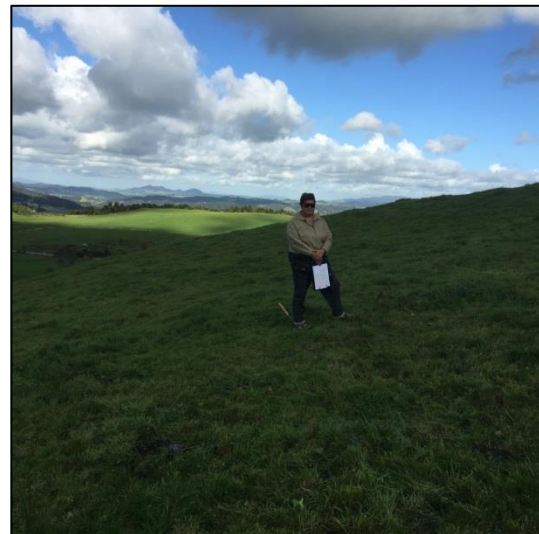
**Site of PRC43 (viewed to the EAST)**

Drill collar not visible but possibly located by probe. No physical or environmental evidence of drill site found.

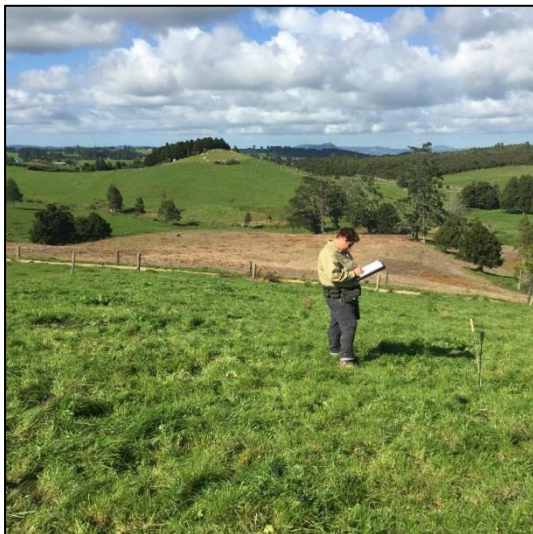
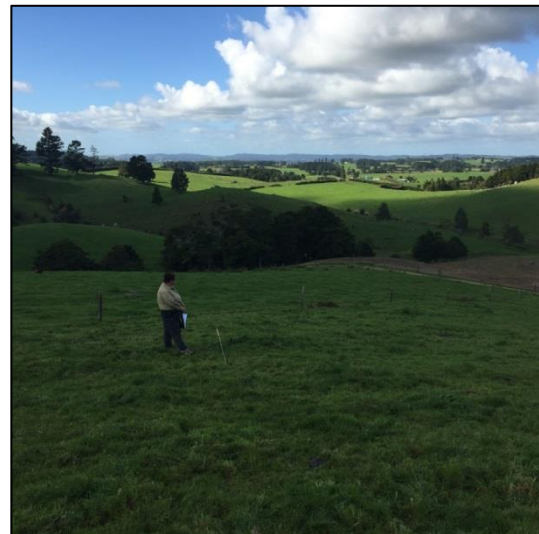
Site of PRC44 (viewed to the SOUTH)

Drill collar not visible but possibly located by probe. No physical or environmental evidence of drill site found.
