Rehabilitation of Drillsites Diamond Drilling Program 2016-2017

EP 51985 Puhipuhi

Evolution Mining New Zealand

2016 Exploration Drill Program Rehabilitation Survey Results

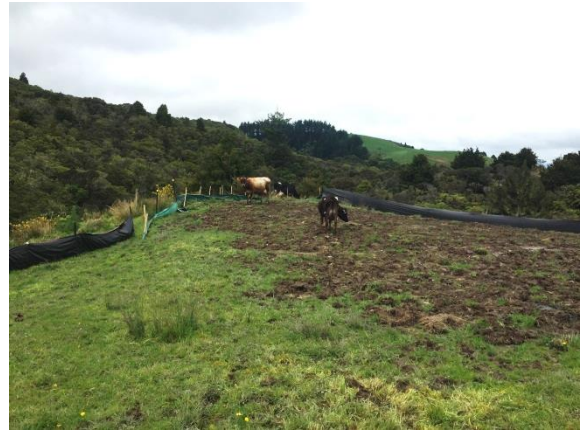
Site PDH05/PDH06 after seeding (22/09/2016), silt fences remain in place

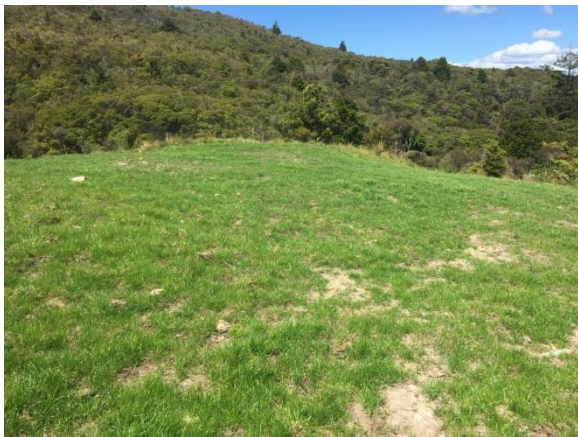
Site PDH05/PDH06 after successful grass take and removal of erosion controls (02/11/2016)

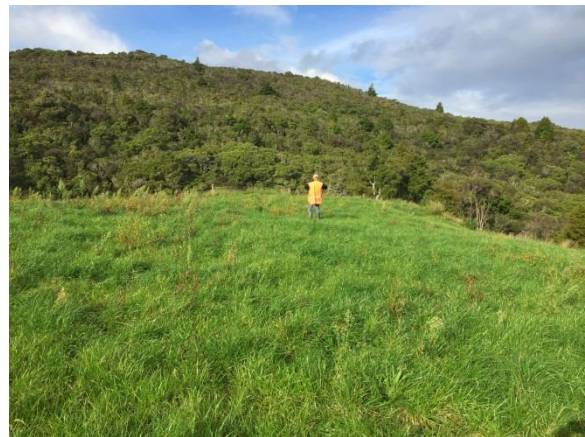
Site PDH05/PDH06 after successful grass take (28/04/2017)

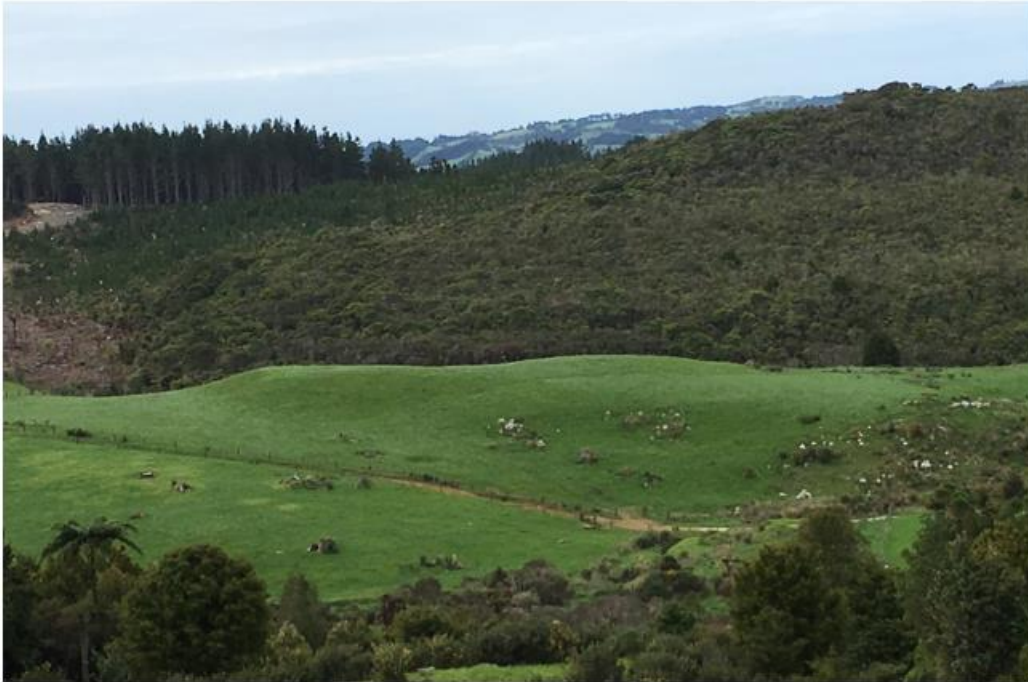
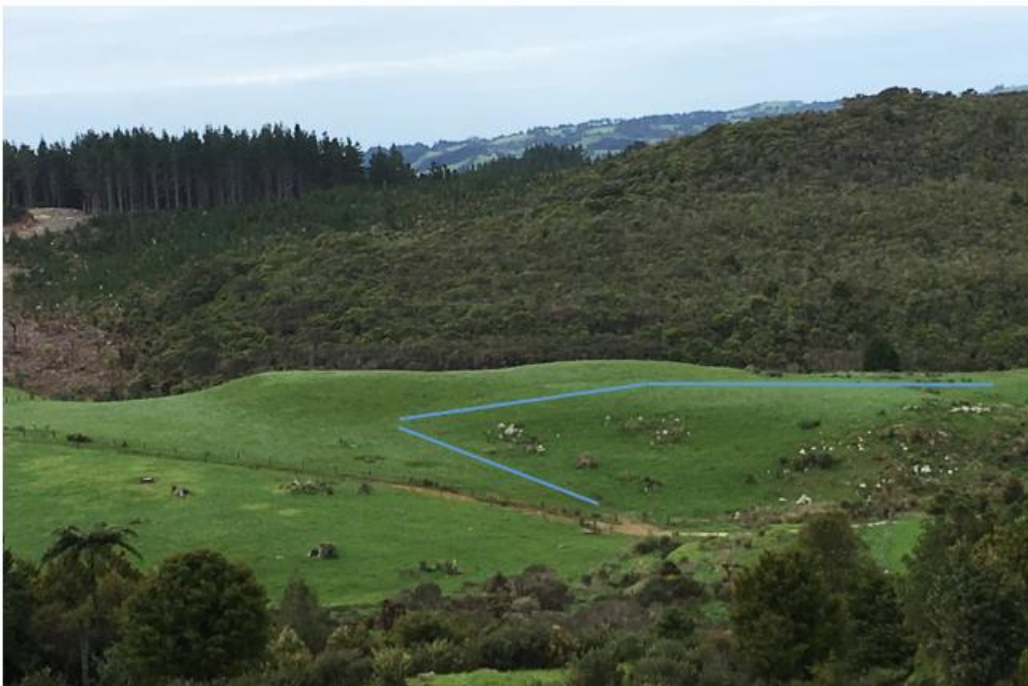
The drill site and associated access track have been mechanically contoured and seeded. There has been significant grass growth over the rehabilitated areas. The rehabilitation measures have been successful.

PDH05 Drill site and access route following rehabilitation, view to East, 23/05/17.

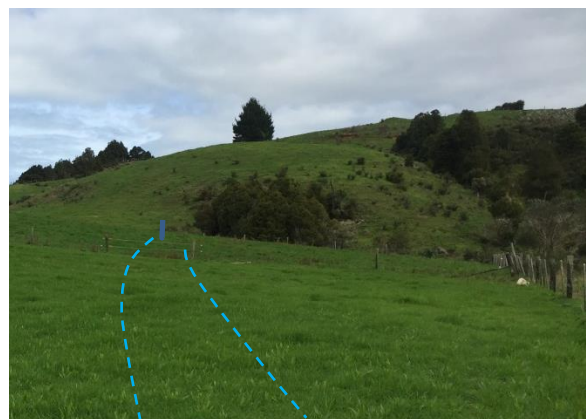
The drill site and associated access track have been mechanically contoured and seeded. There has been significant grass growth over the rehabilitated areas.

**PDH07 following rehabilitation; position of
access route shown in blue 23/05/2017**

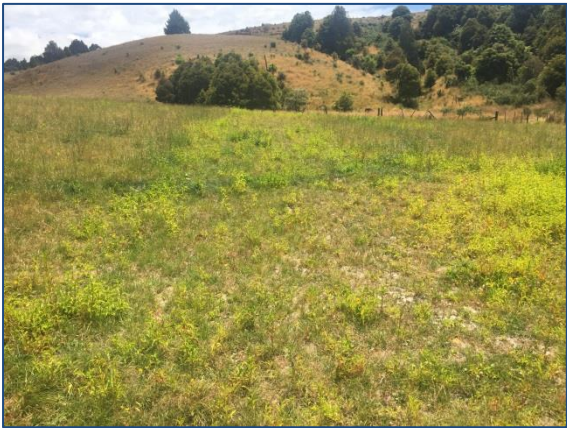
**Site PDH07 after successful grass take
(10/01/2017 – view to west)**

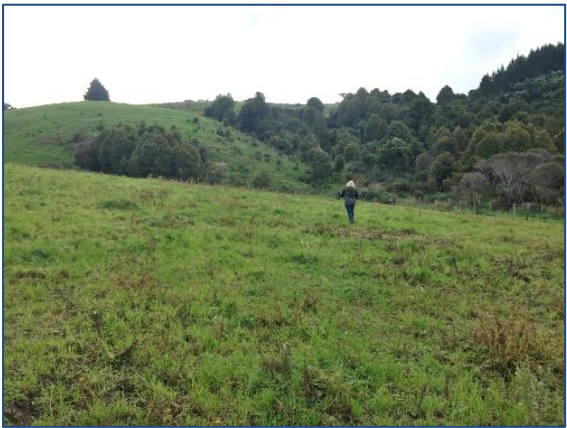
**Site PDH07 after successful grass take
(28/04/2017 – view to west)**

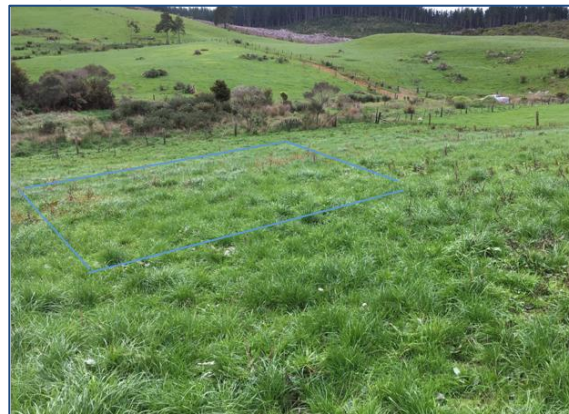
**Site PDH07 after re-establishment of grass
(23/05/2017 - view to east); drill pad position in blue**

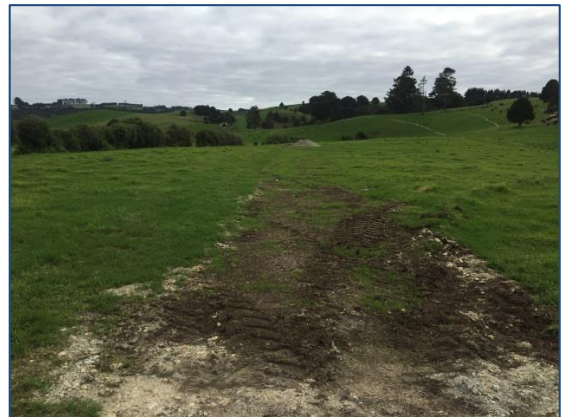
Paddock grass (kikuyu) had begun to establish itself through the crushed limestone substrate by March 2017. New grass cover was partly established by May 2017, following removal of limestone, replacement of topsoil, and hand-sowing of rye grass seed during April 2017.

Site PDH08, view to north, showing reinstated topsoil and grass on access track (23/05/2017)

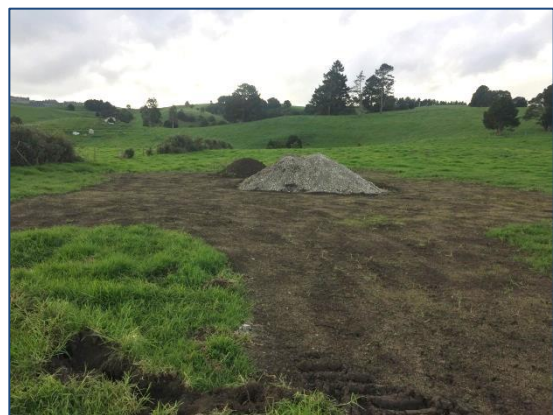
Site PDH08 following removal of crushed limestone, replacement of soil and seeding (28/04/2017). Small heap of limestone left at landowner's request.

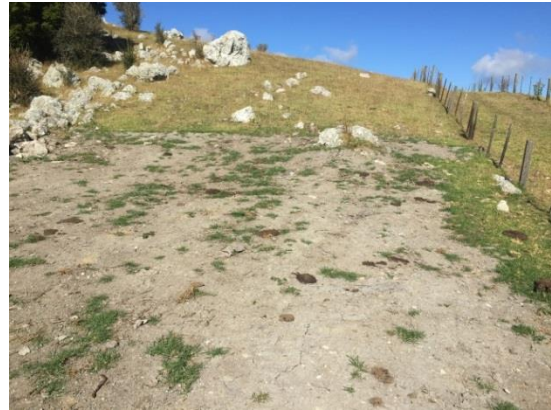
**Site PDH09_09A showing initial grass regrowth
(02/02/2017)**

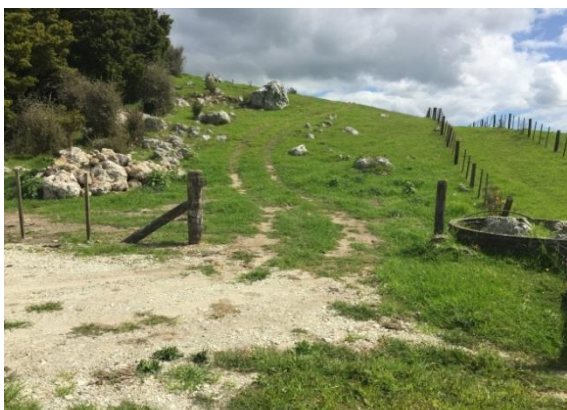
The drill site and associated access track have been mechanically contoured and seeded. There has been significant grass growth over the rehabilitated areas. The rehabilitation measures have been successful.

**Site PDH09_09A after successful grass take
(20/03/2017)**

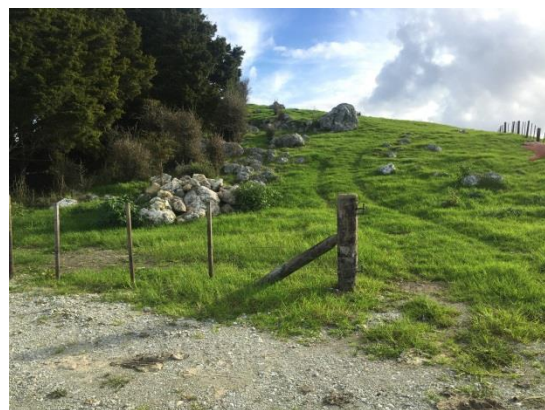
**Site PDH09_09A after successful grass take
(28/04/2017), all views to west**

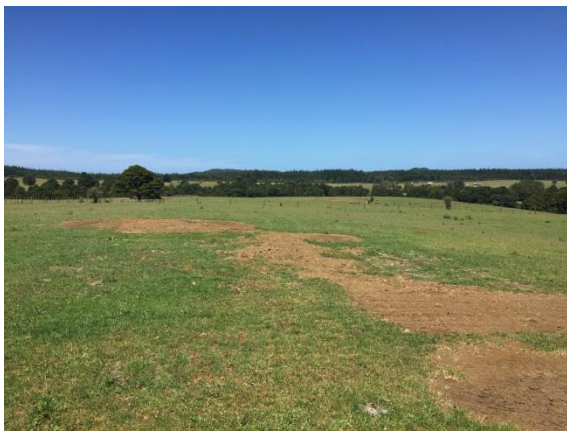
**Site PDH10 after mechanical contouring
(19/12/2016), view to north**

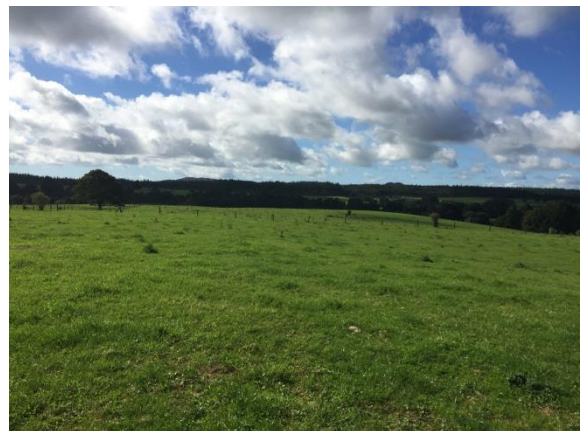
The drill site and associated access track have been mechanically contoured and resowed with pasture grass (rye). There has been significant grass growth over the rehabilitated areas, as shown in the images below. The rehabilitation measures have been successful.

**Site PDH10 showing substantial grass regrowth
(18/04/2017), view to north**

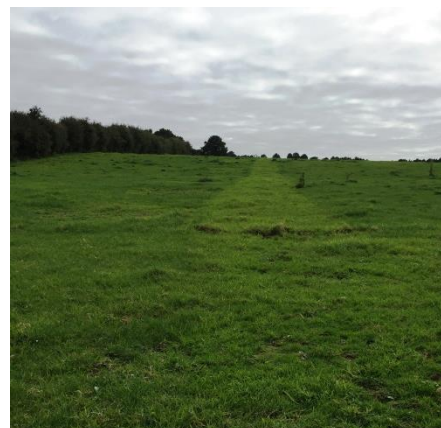
**Site PDH10 showing grass cover restored to
access track (23/05/2017), view to north**

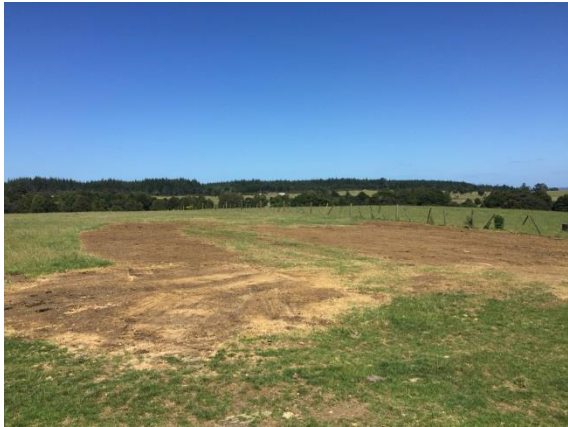
**Site PDH11 after mechanical contouring
(19/12/2016)**

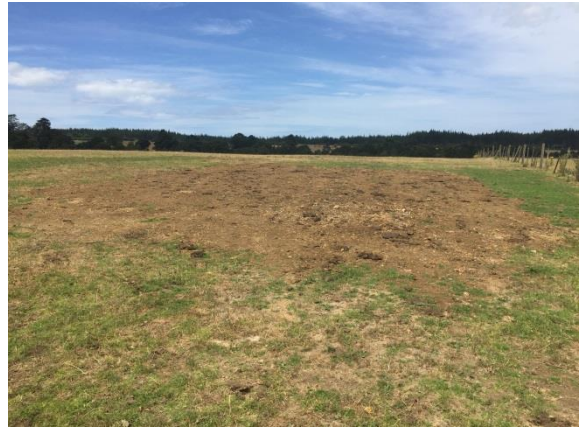
The drill site and associated access track have been mechanically contoured. There has been significant grass growth over the rehabilitated areas. The rehabilitation measures have been successful.

**Site PDH11 showing initial grass regrowth
(06/01/2017)**
