Summary of Environmental Baseline Monitoring

STEVE PEARCE

PATTLE DELAMORE PARTNERS LTD

28TH MAY 2017

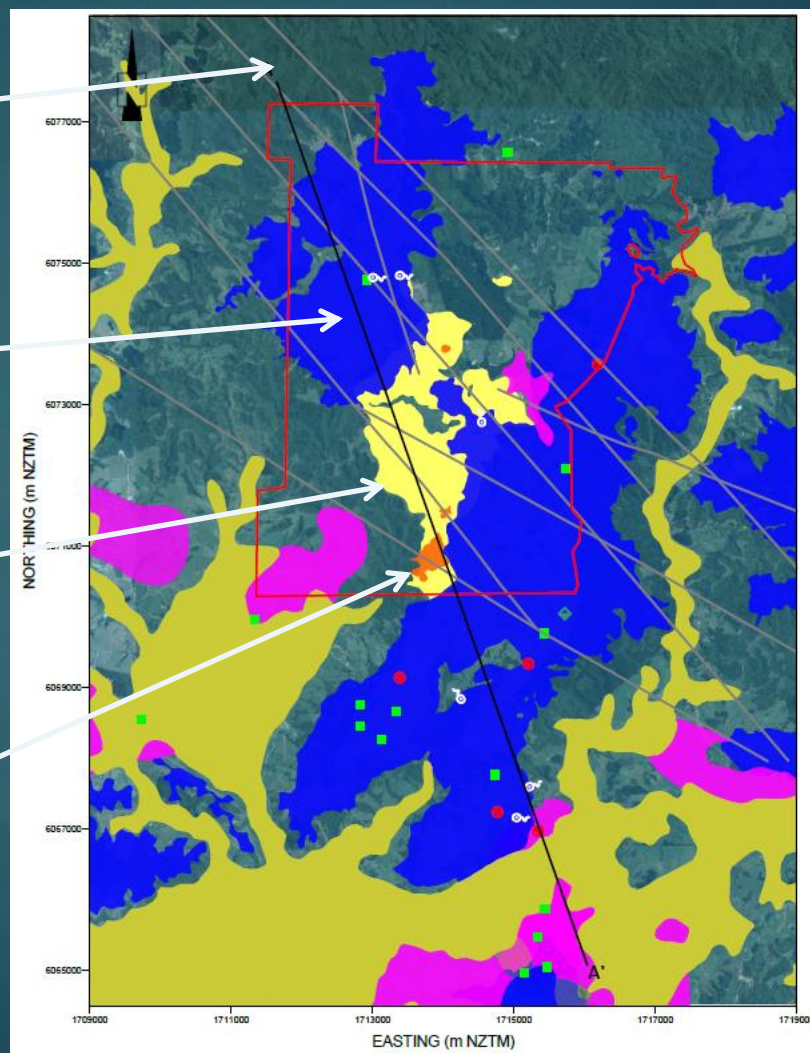
The geology is dominated by old volcanic deposits

- Originally greywacke (grey)
- Volcanics created areas of lava flows - basalt (blue)
- Some low lying areas were an old lake (yellow)
- There were hydrothermal vents that deposited sinter (orange)

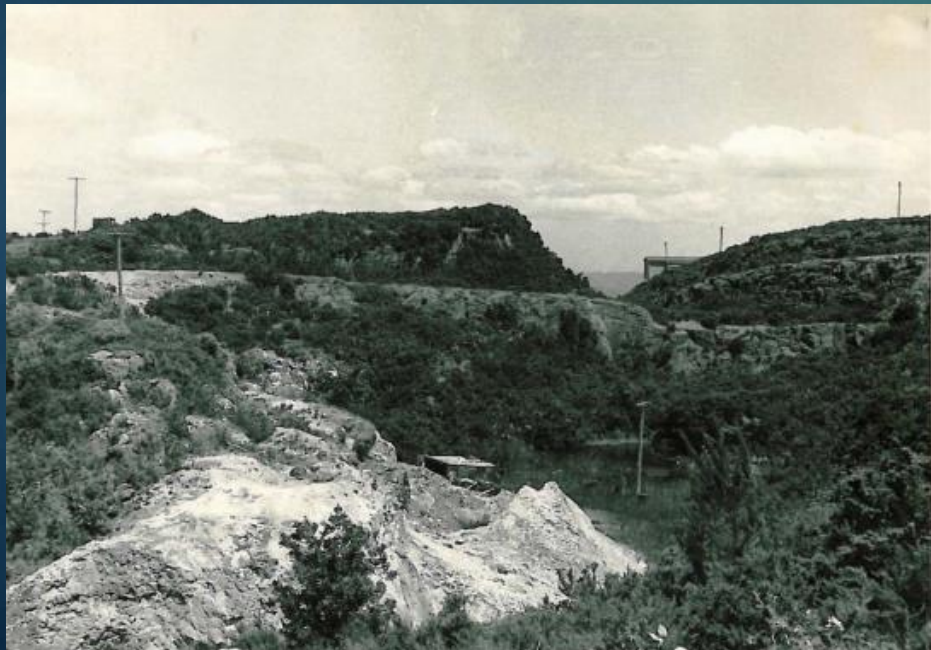
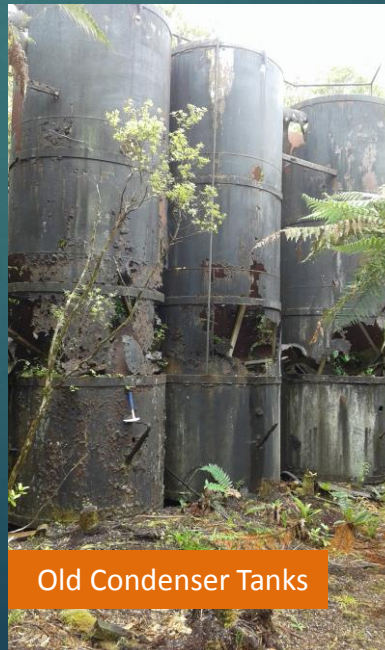
Old Condenser Tanks

- ⌘ 1882 - Alluvial cinnabar discovered
- ⌘ 1907 - Quartz outcrops worked
- ⌘ 1910 to 1945 - Periodic underground and opencast mining activities
- ⌘ 1939 to 1945 - ~15 tonnes of mercury produced, demand driven by WWII
- ⌘ 1945 - Mine closed after WWII following dramatic drop in mercury price

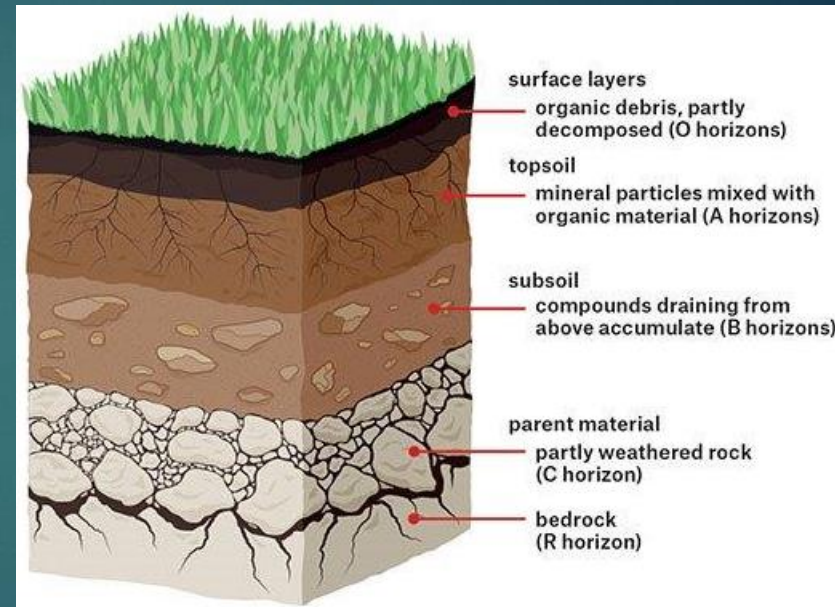
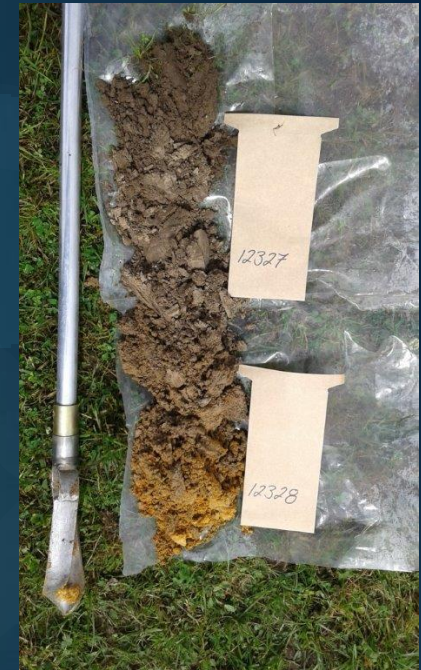
Mercury generally highest in soil C horizon

- ∴ Distribution of mercury within the soil profile investigated
- ∴ Samples taken from A, B and C soil horizons
- ∴ Samples taken over areas of sinter shows metal concentrations increased with soil depth
- ∴ Samples from non-sinter areas showed no relationship with soil depth

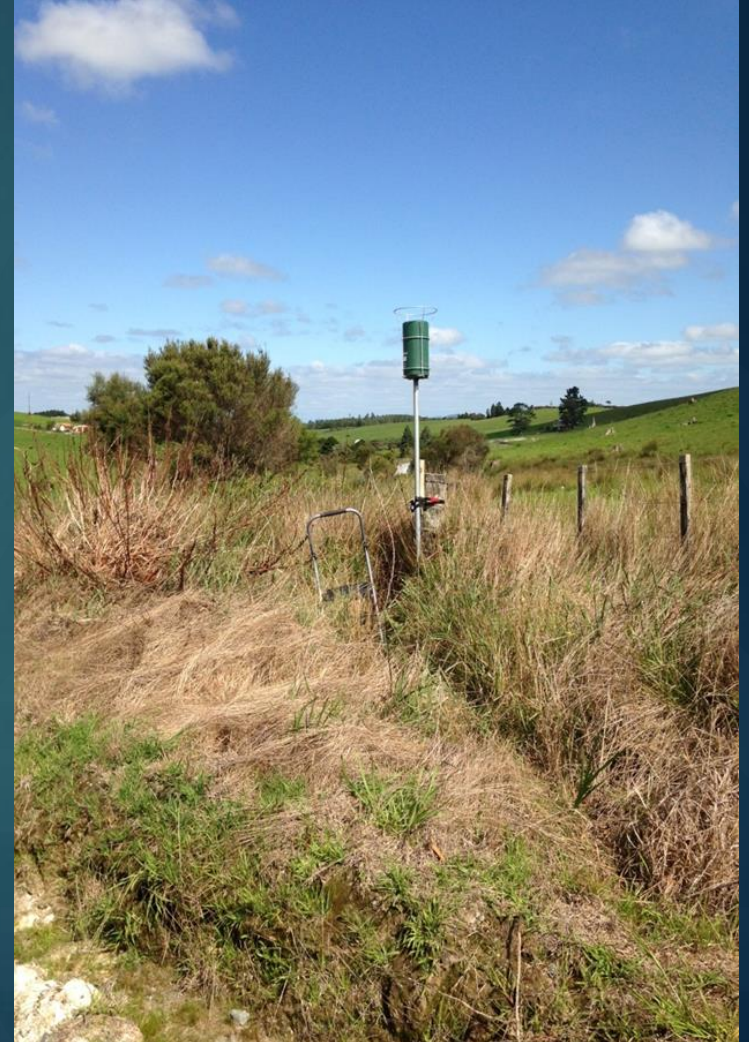
Dust levels low in area

- ∴ Dust deposition rate monitoring was undertaken to establish baseline levels in the area
- ∴ Three gauges were monitored for 9 months
- ∴ One gauge tampered with then went missing so a fourth site was used
- ∴ All readings below 2 g/m²/30 days with the majority below 1 g/m²/30 days which is typical for NZ
- ∴ The MfE recommend a trigger level of 4 g/m²/30 days i.e. 6 g/m²/30 days for any large scale dust generating activity in the region

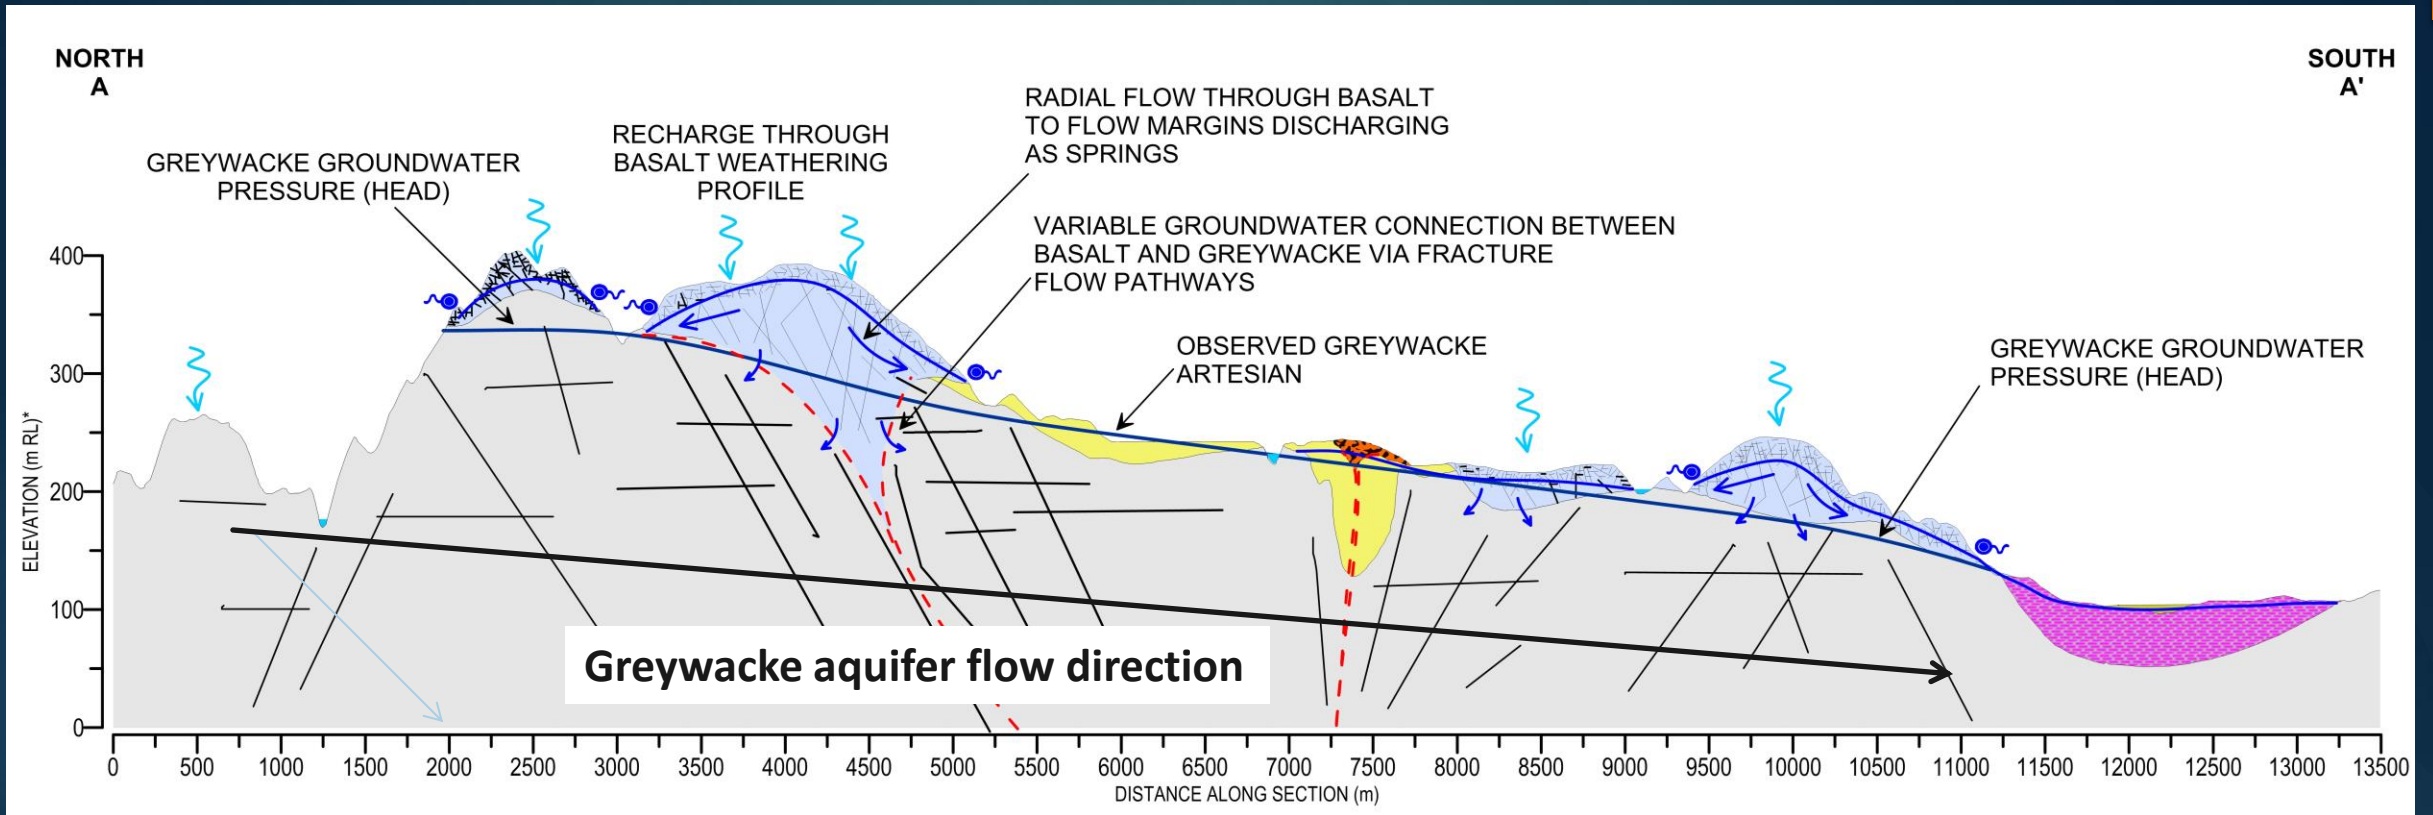
There are three aquifers in the area

- ∴ Water in the deep greywacke aquifer (grey) flows from NE to SW (black arrow)
 - Limited impact on surface water
- ∴ Water in the shallow basalt aquifer flows down hill into streams (blue arrows)
- ∴ Water in the lake bed sediments (yellow) flows downhill into streams

- ⌘ Lies below the Puhipuhi volcanic basalts
- ⌘ Rainwater enters aquifer largely from exposed greywacke to north of tenement
- ⌘ Flow of groundwater is NE to SW
- ⌘ Long residence times
- ⌘ Good quality water, all mercury below detection limit (<0.0001 mg/litre or <0.1 part per billion)
- ⌘ Appears to have little impact on surface waterways (all springs sampled contained water from the basalt aquifer)

- Sits above the greywacke aquifer
- Rainwater fed, good quality, short residence times
- Flows down hill into streams and springs (blue arrows)
- Main source of water supply in the area
- One spring had mercury greater than detection limit (0.0002 vs <0.0001 mg/litre). NZ drinking water standard is 0.007 mg/litre so concentration measured was 3% of the standard

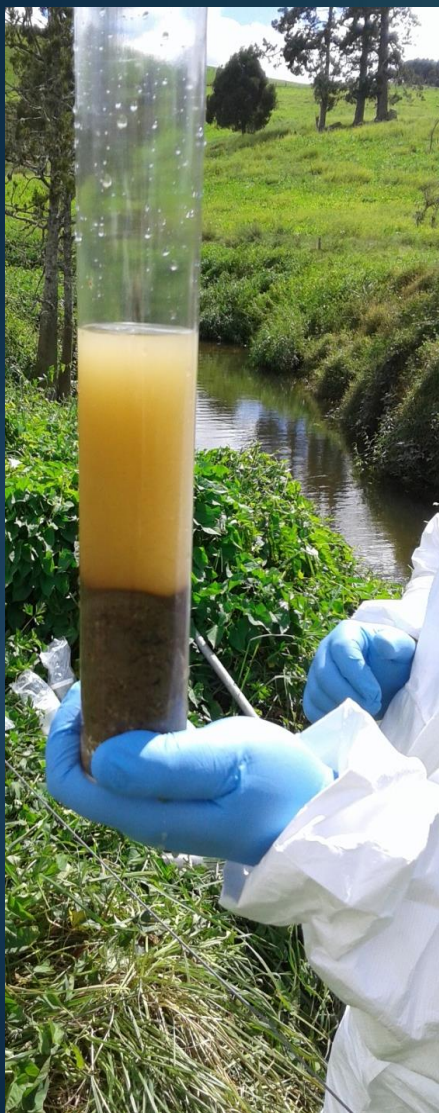
Stream
sediment
samples

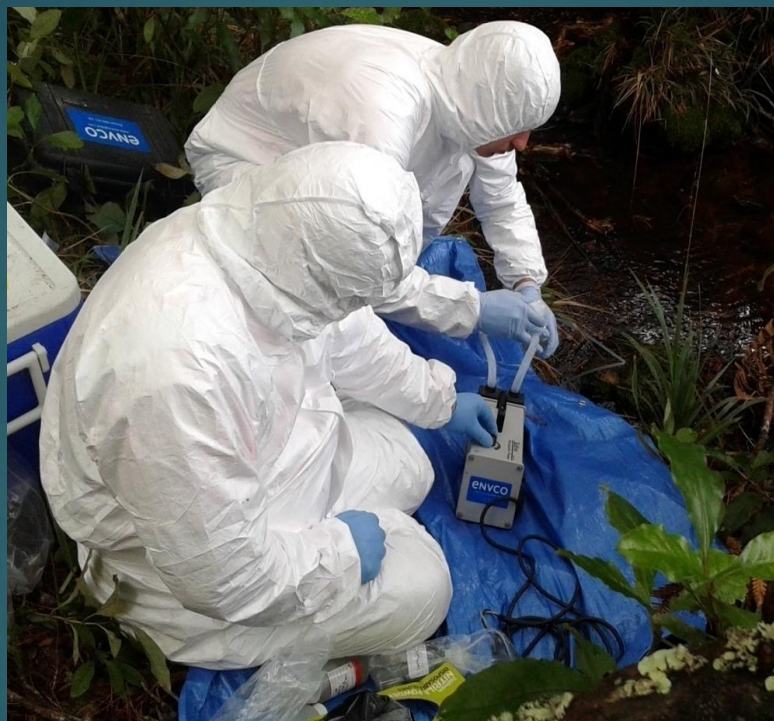
Protective suits worn by
staff to avoid accidentally
contaminating the water
they are sampling

- ∴ Took measures to get most accurate measurements possible
 - Began downstream, furthest away from mercury source
 - Worked upstream to minimise risk of contaminating the next sample
 - Replaced sample tubing and fittings between sites
 - Field staff wore clean suits (white overalls) and masks to minimise sample contamination NOT to protect themselves from anything they were handling
 - Used an international laboratory with lowest detection limits

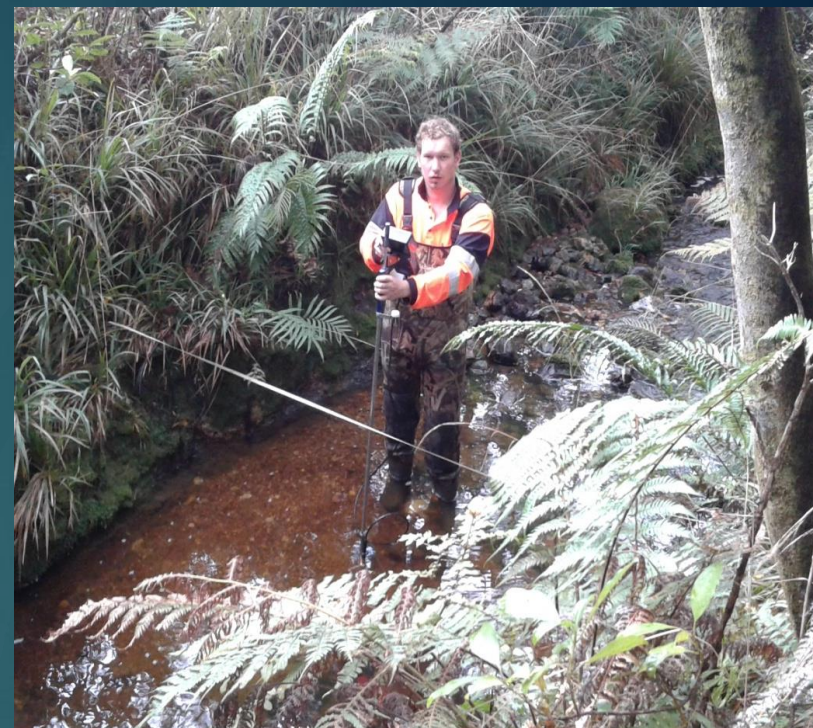
Stream flow
measurement

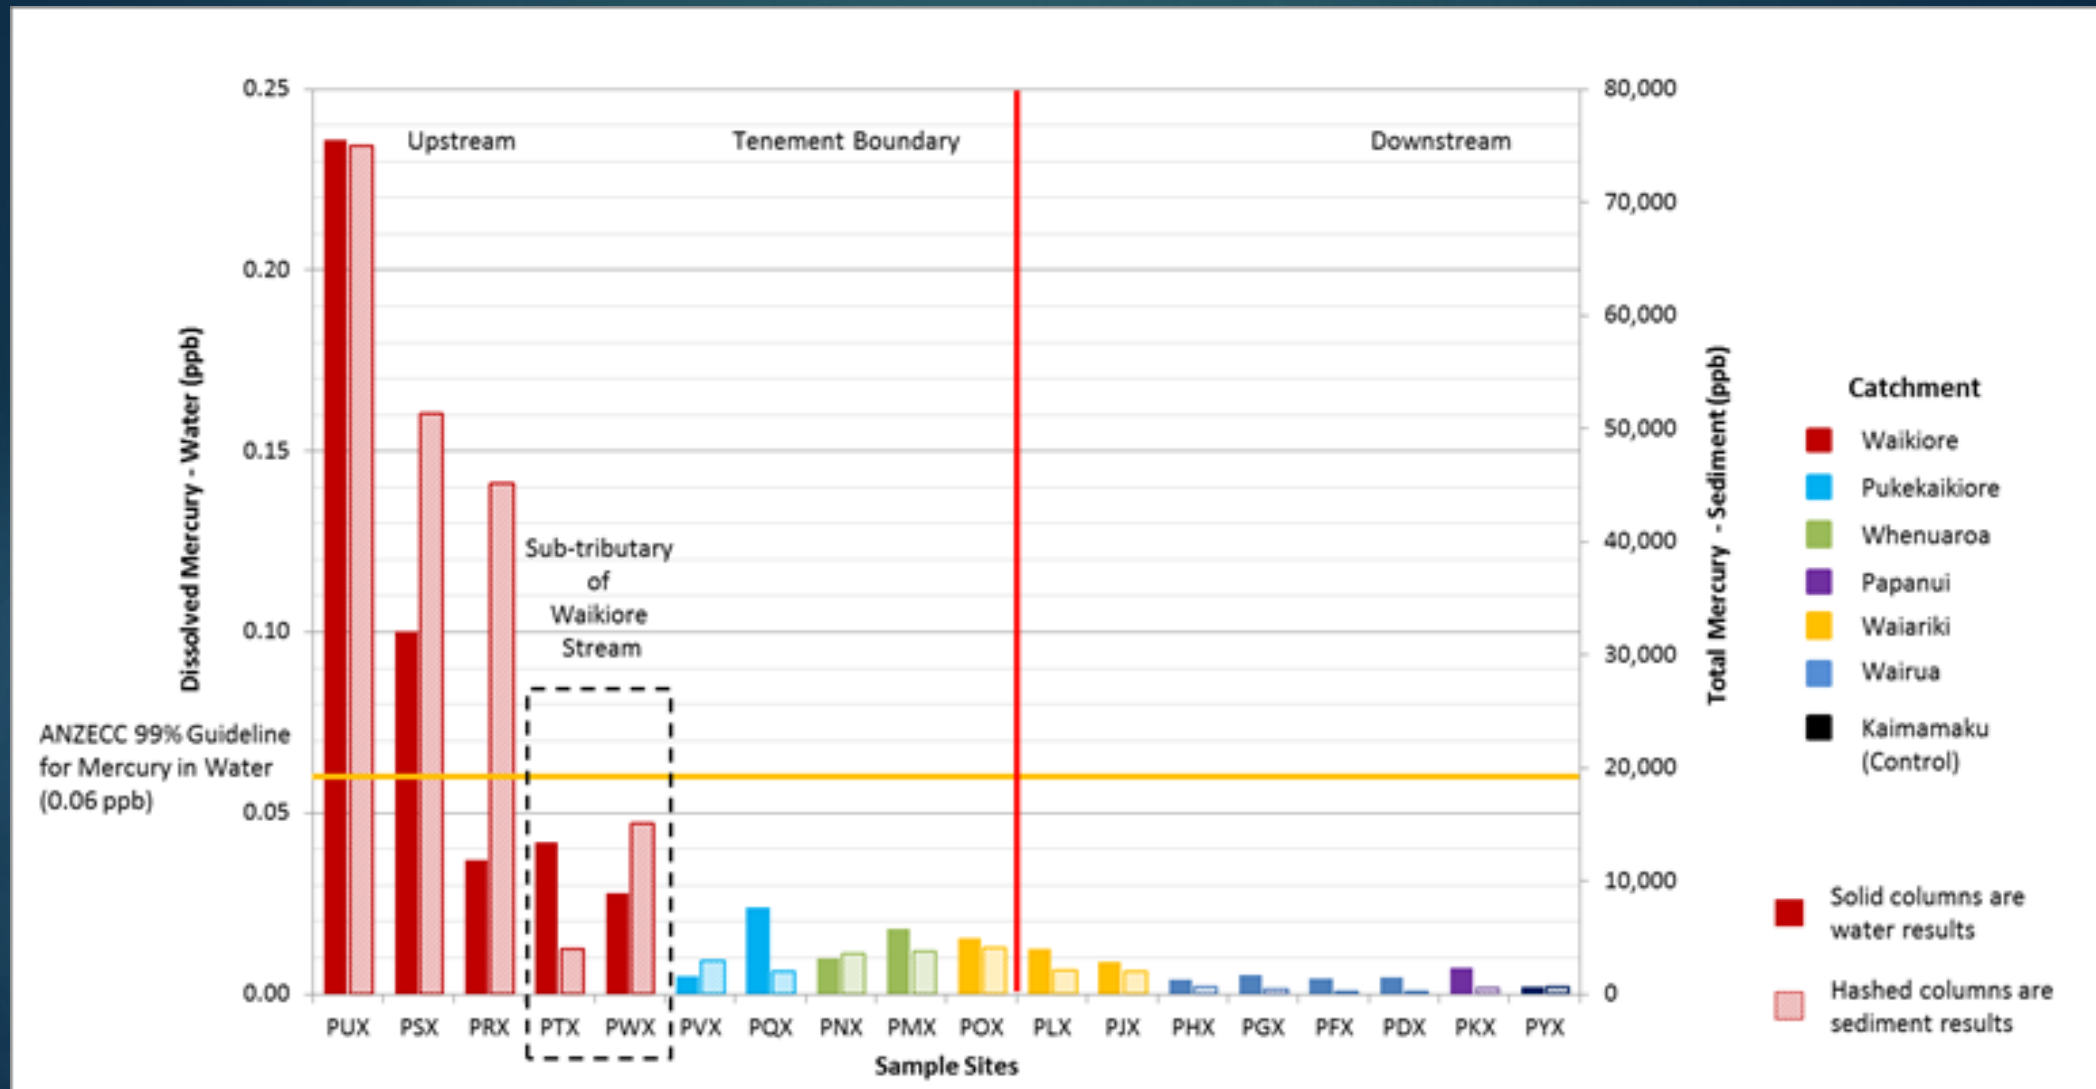
Waikioire catchment is the major source of mercury

- ∴ Concentrations of mercury in both water and sediment were greatest in the Waikiore Stream catchment close to the historic Puhipuhi mercury mine and processing site

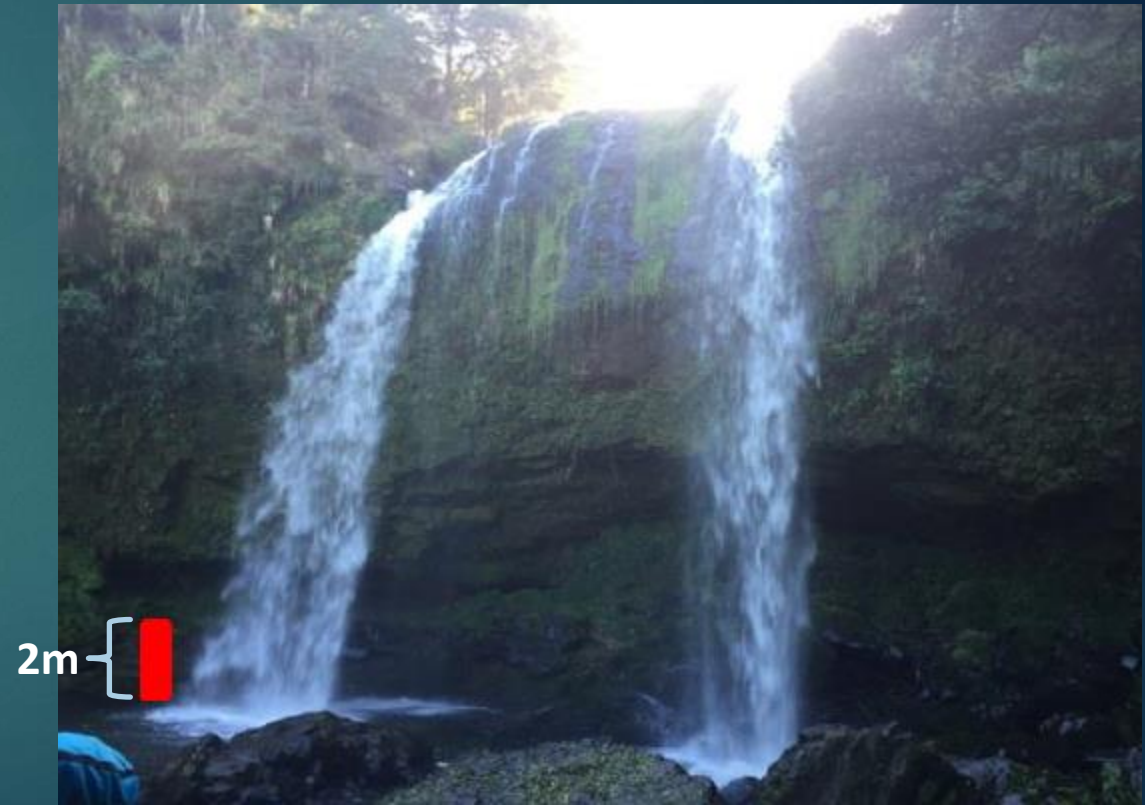
Waiariki waterfall a potential fish passage barrier

- ∴ No eels were caught in the catchment above the waterfall
- ∴ Waterfall was visited, photographed and assessed
- ∴ Considered a barrier due to :
 - a significant overhang
 - overall vertical height (15m)
 - limited resting and wetted areas

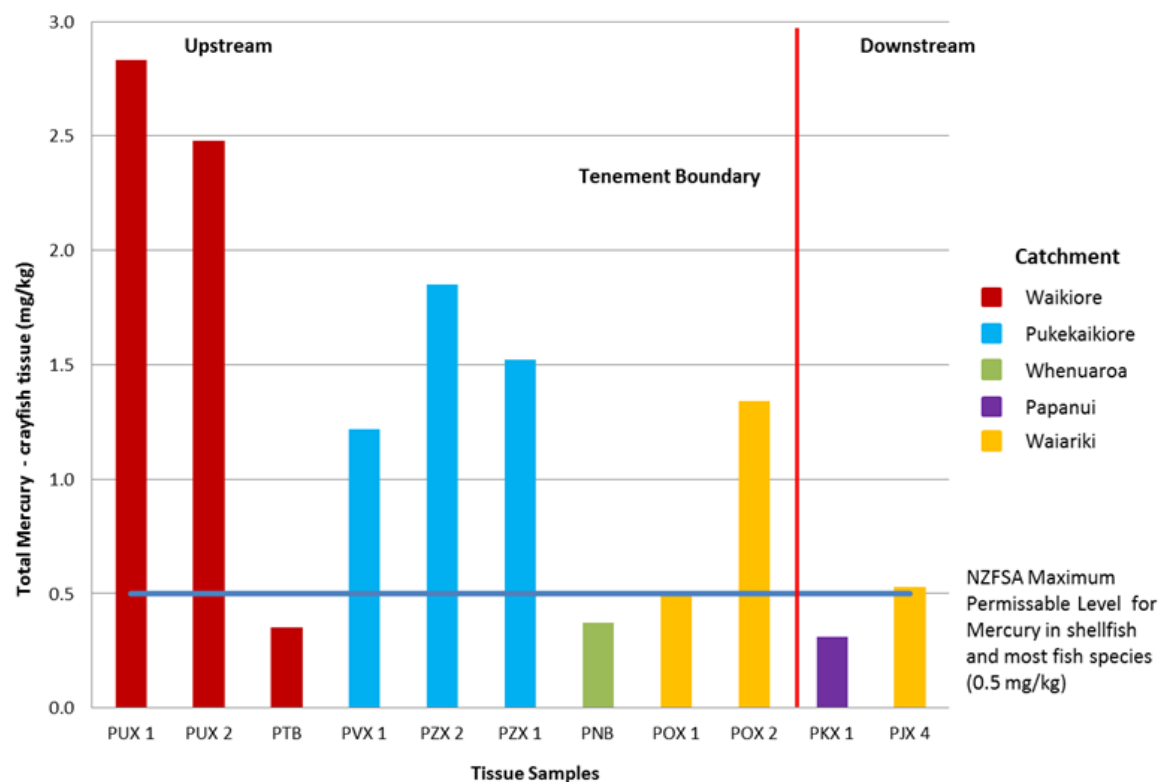
Crayfish

Concentrations of mercury decrease downstream

- ⋈ Mercury concentrations in tissue samples from crayfish within the tenement boundary were above the NZ Food Safety Authority (NZFSA) guideline criteria (0.5 mg/kg)
- ⋈ Mercury concentrations in freshwater crayfish were highest in the Waikiore stream closest to the historic mercury mine
- ⋈ Mercury concentrations in eels caught in the Waiariki and Kaimamaku rivers also exceeded the NZFSA guideline criteria (0.5 mg/kg)
- ⋈ Concentrations of mercury in both eels and crayfish decreased with distance downstream

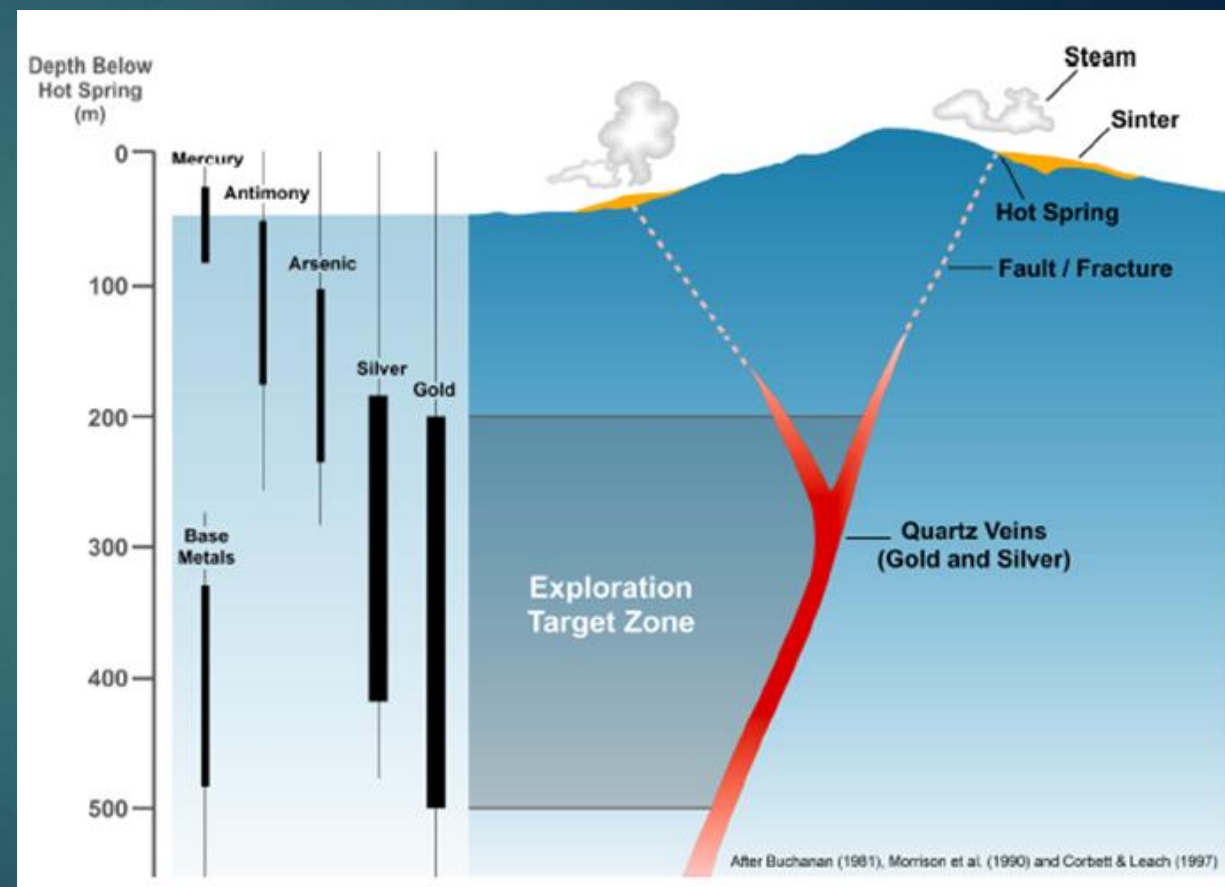
Gold and silver is deposited at depth

- ∴ Exploration drilling required to assess potential
- ∴ Target depth range ~200 – 500 m

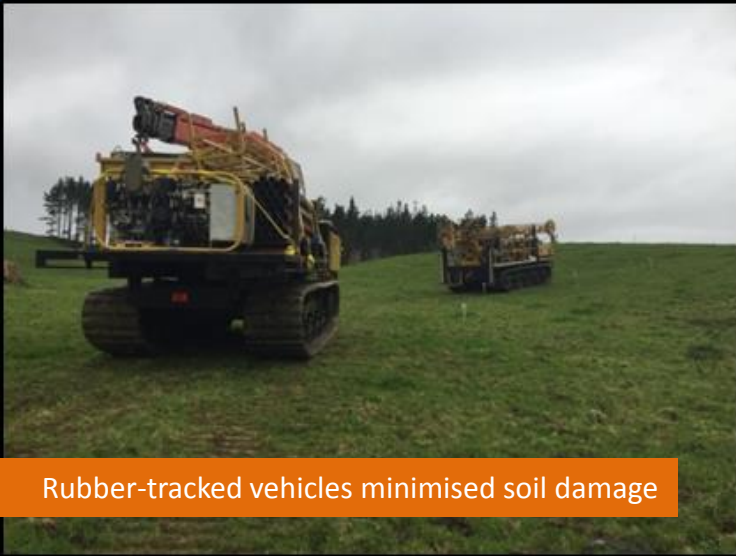
Rubber-tracked vehicles minimised soil damage

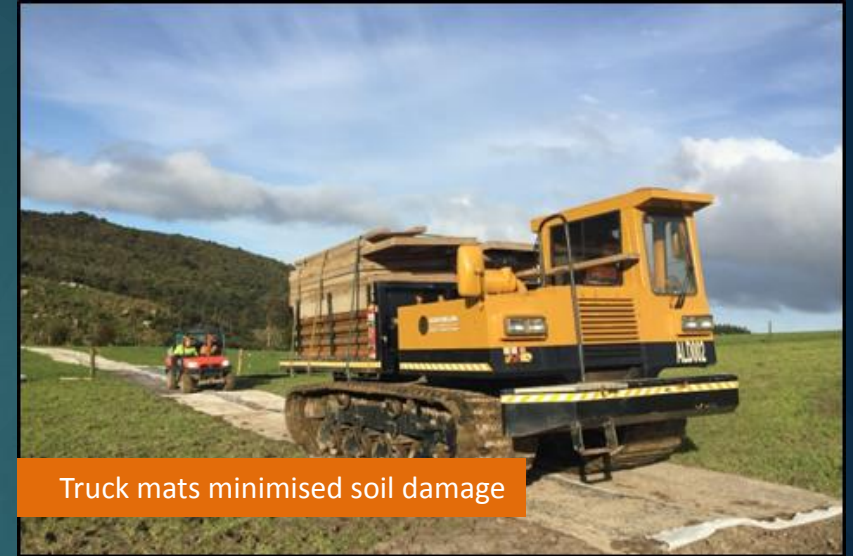
Truck mats minimised soil damage

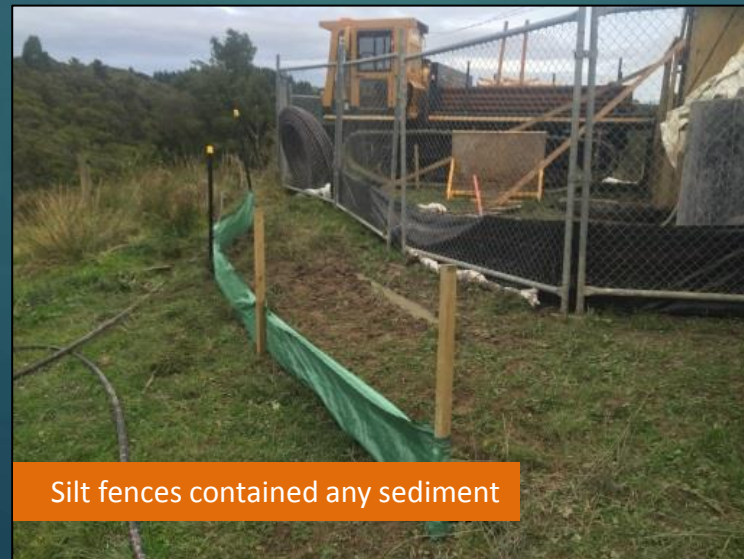
Silt fences contained any sediment

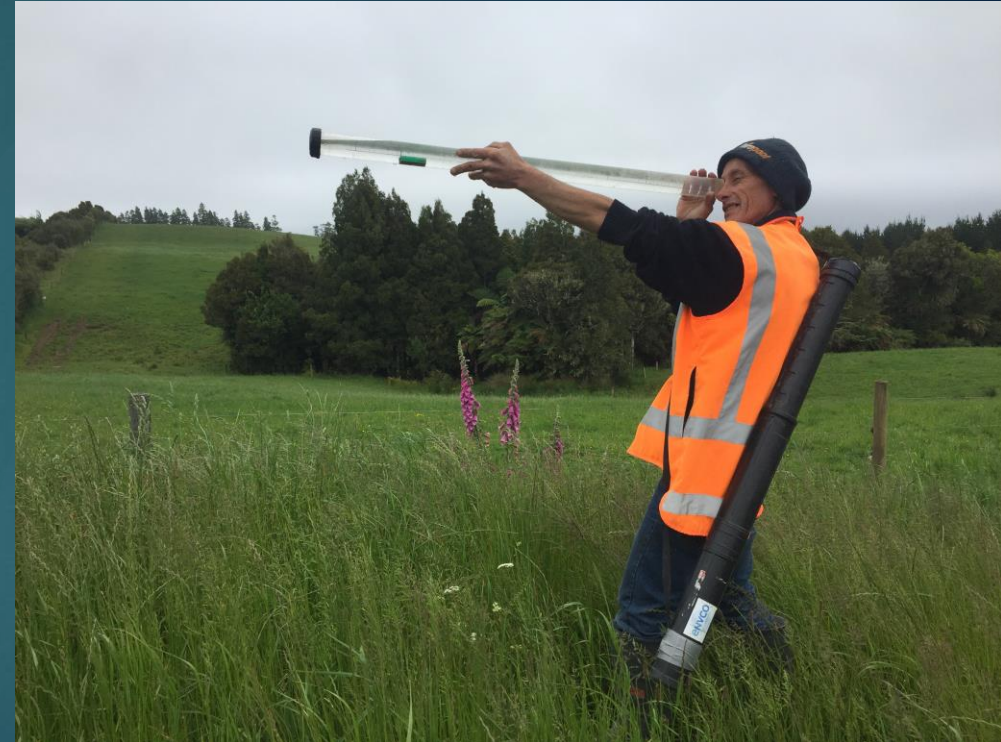
Routine water clarity monitoring undertaken

- ∴ Key potential effect on surface waterways is sediment runoff
- ∴ Clarity tubes were selected as the preferred way of assessing the impact of sediment runoff
 - Ease of use
 - No calibration required
 - Linked to guidelines in the Northland Regional Plan for water clarity
 - Instant results allowing immediate corrective actions to be taken
- ∴ Monitoring carried out three times per week
 - Visual inspections of erosion control measures
 - Surface water clarity monitoring

- ∴ A reduction of $\geq 20\%$ in water clarity between upstream and downstream of the drill site triggered an inspection to determine if the increased turbidity was a result of drilling related activities
- ∴ 288 water clarity readings taken
- ∴ On 2 occasions clarity had decreased by more than 20%
- ∴ Investigations determined drilling activities were not the cause of increased runoff of sediment from pasture

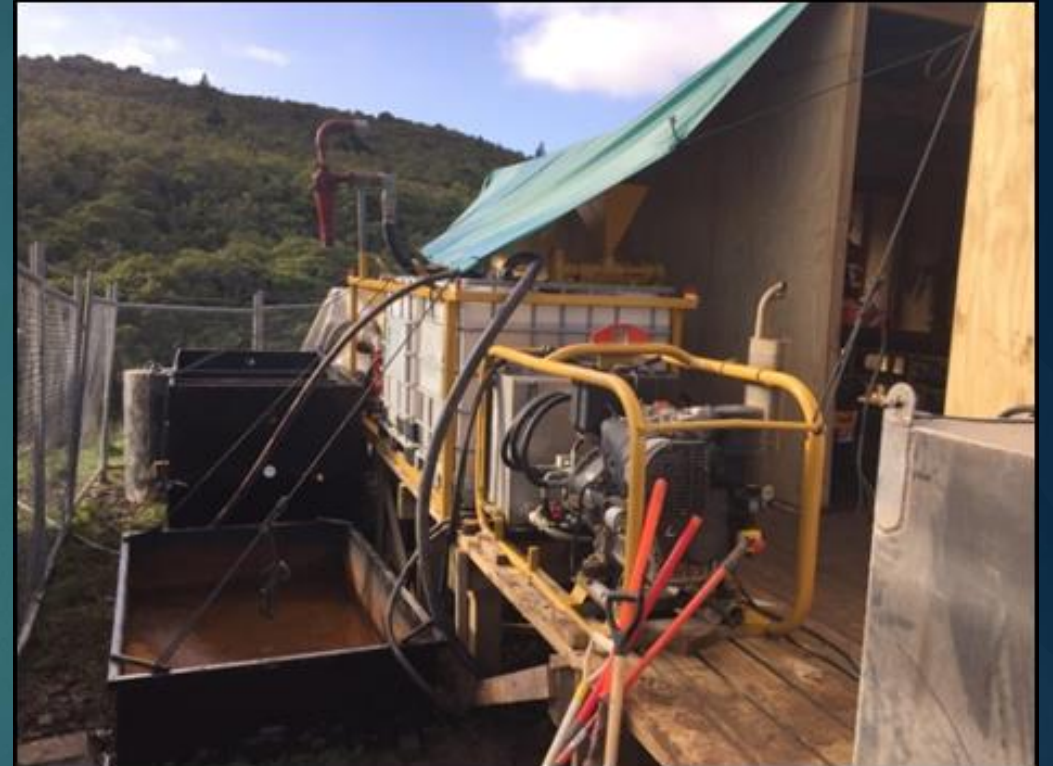
All drilling fluids were disposed appropriately

- ⌘ Drilling cuttings collected in 1,000 litre ICB's
- ⌘ Analysed to determine metal concentrations
- ⌘ Disposed of at approved waste disposal facilities (Class A landfill)

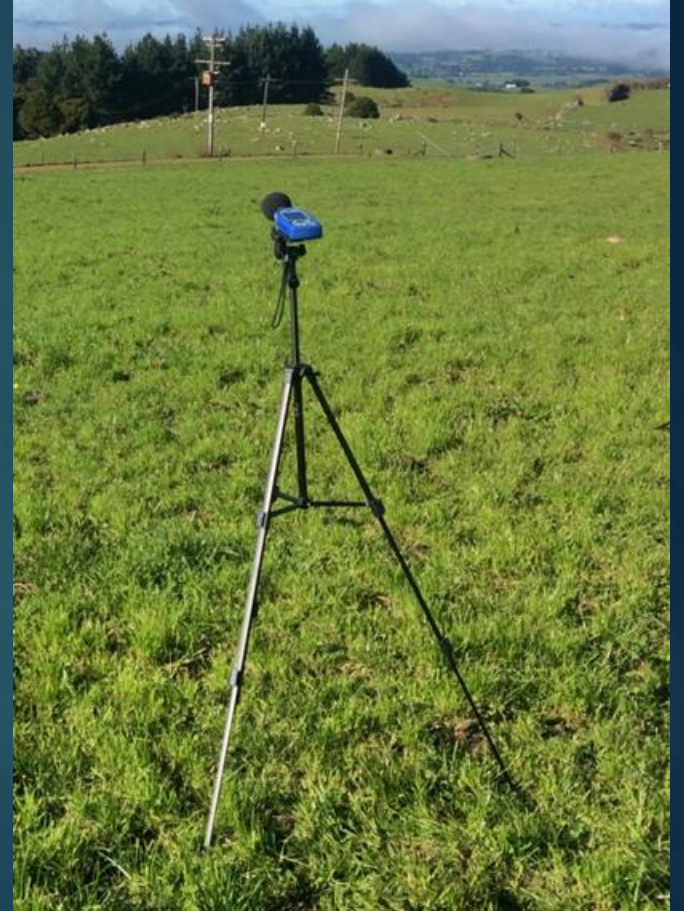
Noise monitoring

- ⌘ Undertaken at three locations, both while the exploration rig was operating and not
 - ⌘ One 60m downwind from the drill rig
 - ⌘ The other two close to the nearest houses (1,000 and 1,400 m away)
- ⌘ Calculated that the sound pressure level of the operating drill rig was 90 dB
- ⌘ In order to comply with the night time District Plan noise levels (40 dB), it was calculated that the drill rig needs to be located ~320m from the nearest property boundary
- ⌘ Neither of the two other monitoring sites were impacted by drill rig noise

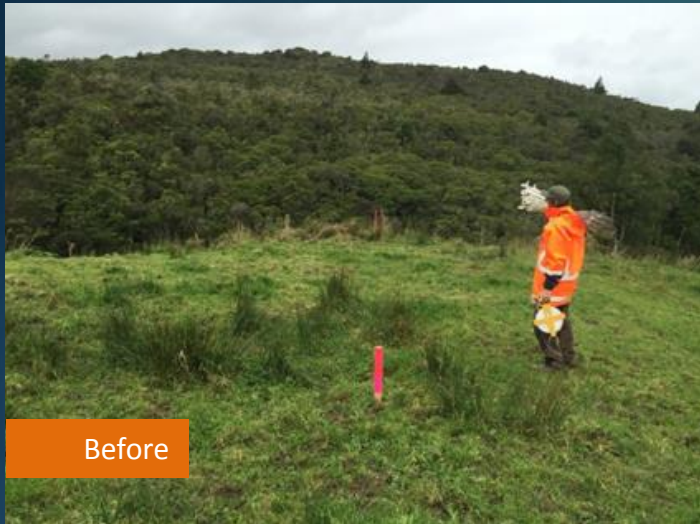
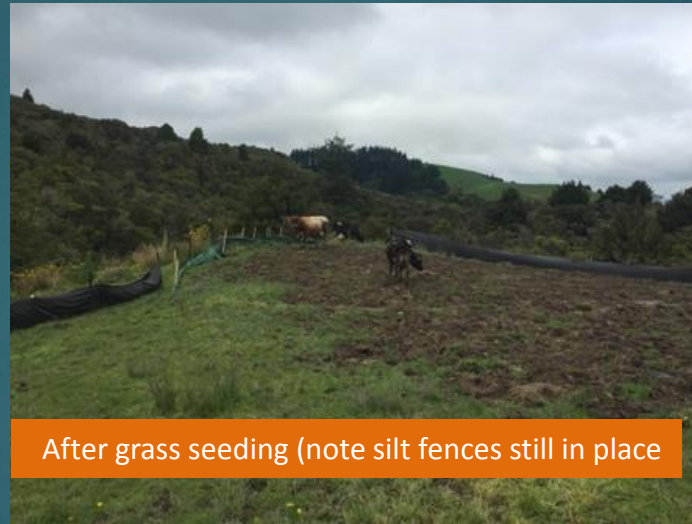
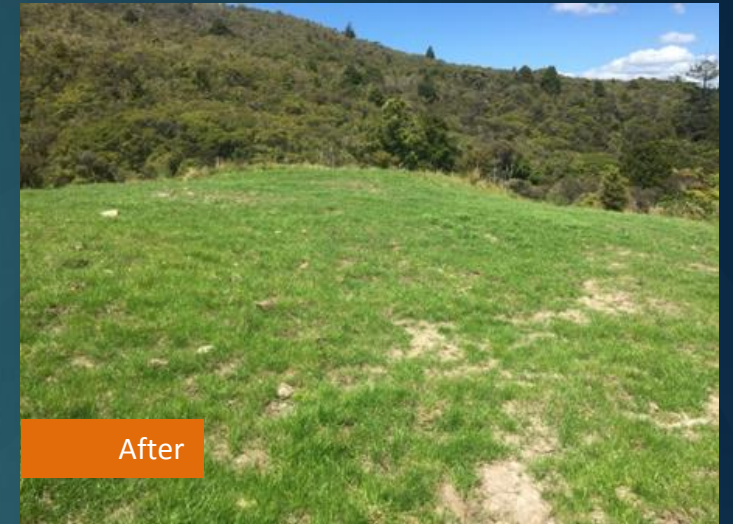
All sites rehabilitated at completion of work

- ▶ All drill sites rehabilitated to ensure no ongoing risk of environmental impact
