## **Review of Historic Exploration Drill Sites and Survey of Legacy Effects in the Puhipuhi area, Northland**

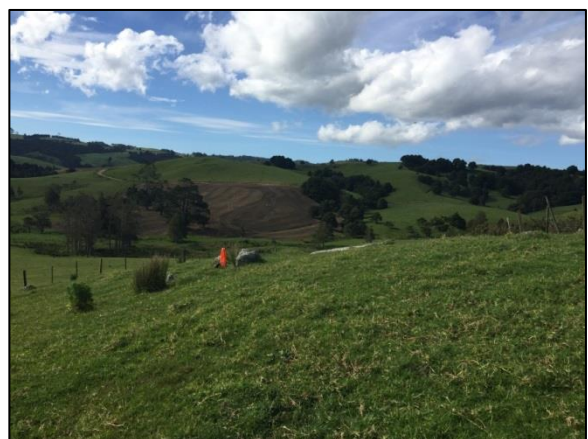
**Site of PPRC6 collar (viewed to the NORTH)**

1. Drill Collars: not visible, not located.
2. Site Condition: no visible signs of groundwater seepage, subsidence, hydrocarbons or erosion. All rubbish had been removed.
3. Sediment Control: no sign of sediment runoff, all cuttings have been removed.

No physical or environmental evidence of drill site found. Drill collars not definitively located with probe due to (buried) boulders present in the area.

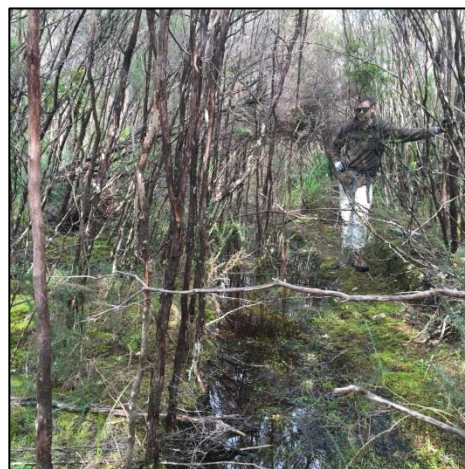
Track leading to Site of PPRC11 and PPRC33
